SERVICE ACTION: RETROFITTING REAR AXLE GROUND STRAP FOR RADIO INTERFERENCE

G12 (7 Series PHEV)

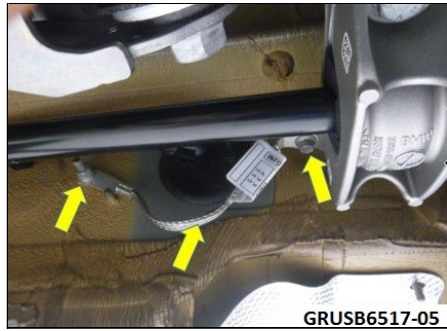
The ground cable from the rear axle to the body was not installed in the vehicles.

1. Raise vehicle on lift.
2. Install ground cable from the rear axle to the body where shown below.

Torque nut and bolt both to 12 Nm.
