## BLINDSPOT DETECTION WARNING: FALSE ACTIVATION

This Service Information bulletin supersedes SI B66 24 16 **dated January 2017**.

| G12 (7 Series Sedan) | | | |

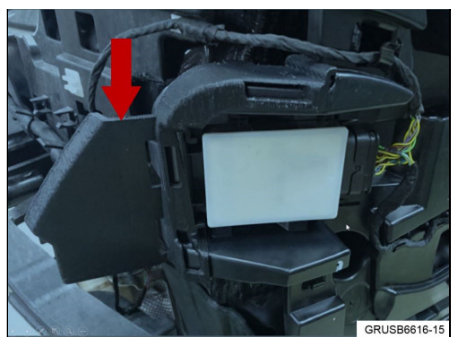
Incorrect detection of Blind Spot Warning sensor (HC2-sensor). The radar waves are incorrectly

scattered

This sensor shield prevents the incorrect scattering of the radar signals at the rear bumper, which causes false warnings.

2. Remove the rear bumper panel following repair instructions REP 5112156 – removing and installing rear bumper panel.
3. Install the sensor shield as shown in the picture.
