## INTERIOR REARVIEW MIRROR MOVES OUT OF POSITION

F54 (Cooper, Cooper S Clubman)	F55 (Cooper, Cooper S Hardtop 4 door)	F56 (Cooper, Cooper S Hardtop 2 door)	F57 (Cooper, Cooper S Convertible)
--------------------------------	---------------------------------------	---------------------------------------	------------------------------------

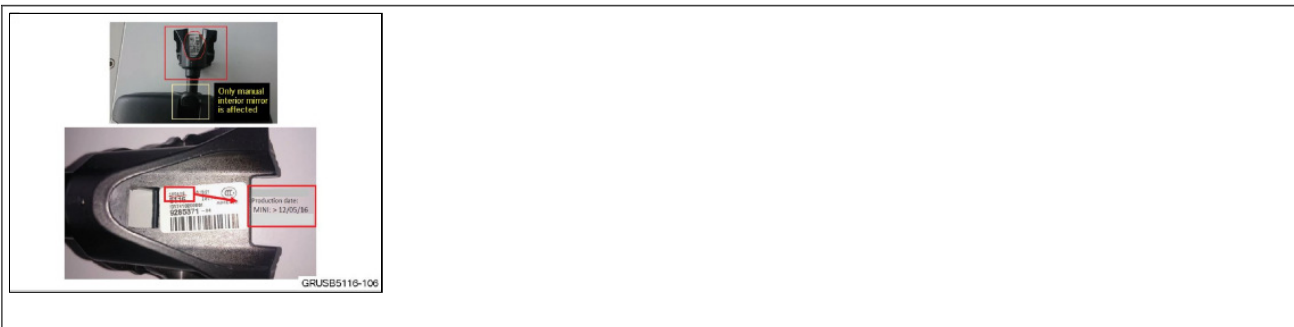
Note: Verifying the production date code for replacement (see graphic below for location). The date code on

part format is in “dd/mm/yy.”(May 12, 2016)

Replace mirror with the standard EPC part number, per repair instructions “REP 51 16 063 Removing and Installing/replacing interior mirror”.
