## HEADLINER INTERFERENCE WITH ROLLOVER TRIM PANEL

F57 (Cooper, Cooper S Convertible)
------------------------------------

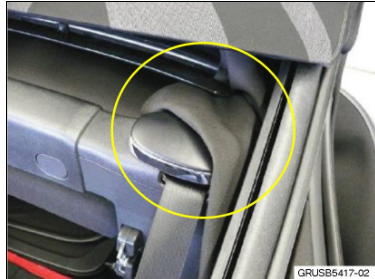
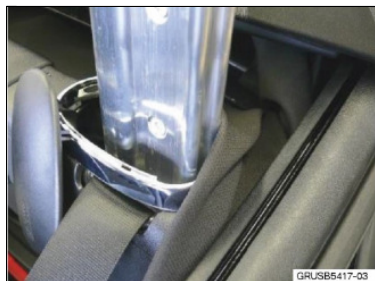
Rollover protection trim panel interferes with headliner during roof retraction.

Note: No safety issue is created by this failure to completely stow headliner. Rollover protection deployable

while headliner on top of trim panel.

Headliner fabric is not sufficiently relaxed to free itself from trim panel.

Open and close convertible top multiple times allowing the top to rest in the open position for some period of time. This process will relax the fabric and allow it to slide over trim panel.
