## CONVERTIBLE TOP REAR WINDOW DAMAGE

F57 (Cooper, Cooper S Convertible)

Produced after 11/2/15

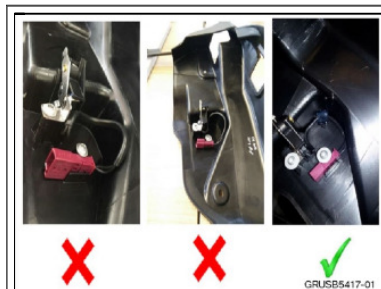
The micro-switch that is supposed to detect an incorrectly positioned luggage compartment cover during closing is improperly positioned due to interference from the micro-switch wiring harness.

1. Remove luggage compartment lining at the rear left in accordance with the repair instructions 51 46 020 "Removing and installing recess for left or right deflectors".
2. Position the cable of the micro-switch as shown (on the right below) and secure with adhesive (part number 81 22 2 351 255) to the luggage compartment trim.
