THE ENGINE WILL NOT START AND THE DME IS NOT RESPONDING

F48 (X1)

With the B46O engine produced to 12/2015

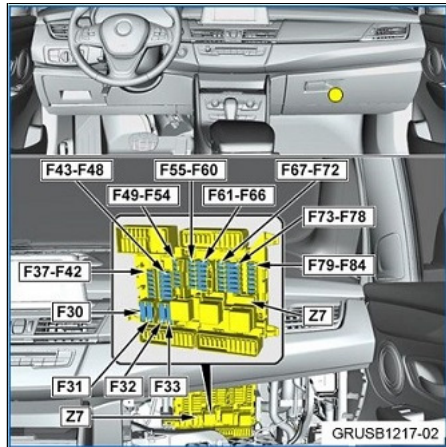
Fuse 83 (5A) is open.

When the turbocharger coolant pump is activated by the DME, the initial starting current could briefly exceed the 5A rating of Fuse 83 causing this fuse to blow.

Replace F83's "5A" fuse with a "7.5A" fuse only

1. Install a replacement 7.5A fuse.
2. Make a change on the fuse reference card in the front power distribution box. for F83 from 5A to 7.5A
