## WIND NOISE FROM REAR SIDE WINDOW

G30 (5 Series Sedan)

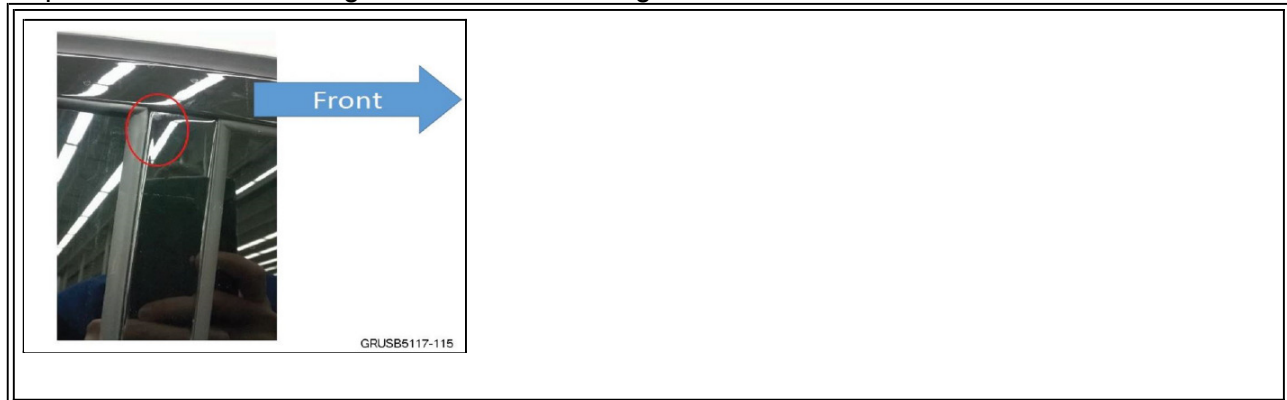
Gap between the window guide and the window guide bar.

**Is there a gap similar to that shown in picture above?**

Replace the window guide after verification of cause.

**NO** — replace the window guide (refer to ISTA Repair instructions “51 34 211 Replacing rubber seal for rear left or right door window”).
