## SERVICE ACTION: CHECK CHARGING OF THE HIGH VOLTAGE BATTERY

This Service Information bulletin replaces SI B61 28 16 **dated January 2017**.

F15 PHEV (X5)

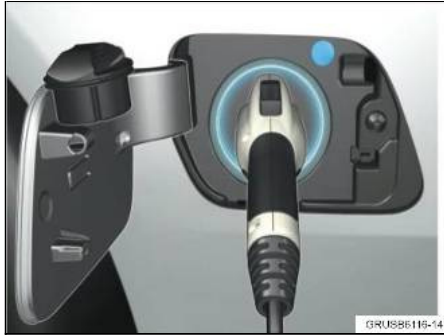
2. Connect Level 2 (220V) charging cable to the vehicle.

Wait 15 seconds until the “Charging Active” blue light is illuminated.

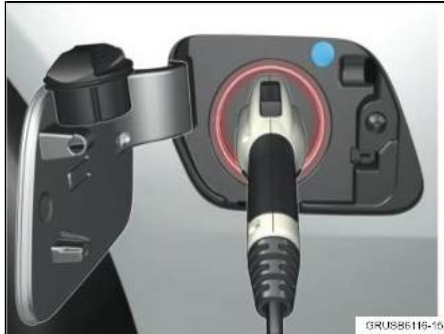
3. **Repeat this step 20 times. Was “Charging Active” indicated in every (all 20) charging cycle attempt?**

**YES** — there are no further actions needed. The KLE charging module is working correctly.

**NO** — Continue to next step.
