TIME DISPLAY (CLOCK) ERROR IN INSTRUMENT CLUSTER

F22 (2 Series Coupe)	F23 (2 Series Convertible)	F25 (X3)	F26 (X4)
F30 (3 Series Sedan)	F31 (3 Series Sport Wagon)	F32 (4 Series Coupe)	F33 (4 Series Convertible)
F34 (3 Series Gran Turismo)	F36 (4 Series Gran Coupe)	F48 (X1 sDrive 28i or xDrive 28i)

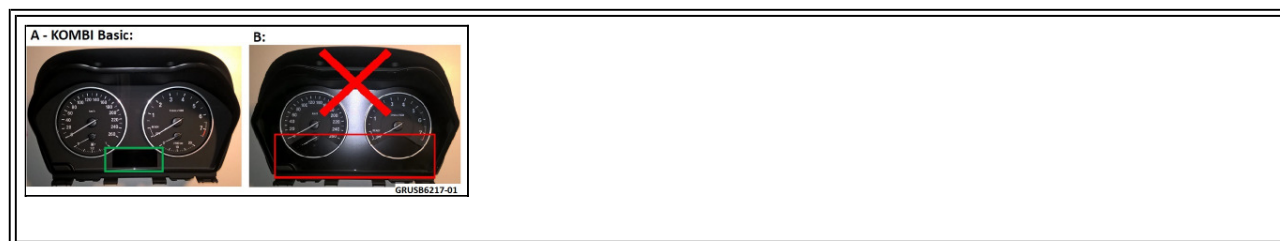
Only the basic Kombi (A) is affected. The basic Kombi can easily be identified by the full gauge set under the speedometer and tachometer as seen in figure (A). The extended version (B) is not affected.

Reprogram instrument cluster (Kombi) in the affected group of vehicles with ISTA/P or ISTA 4 to I-Level 17-03-504 or higher.
