SI M61 01 17  
General Electrical Systems

April 2017  
Technical Service

## WINDSHIELD WASHER SYSTEM NOT WORKING

F60 (Cooper, Cooper S, JCW Countryman)

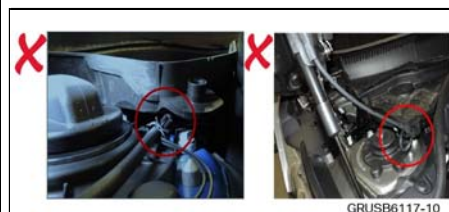
Restriction of supply hose caused by:

- Kink in hose
- Incorrect hose routing
- Pinched in hood closure

Reroute washer hose to eliminate restriction to fluid flow.
