SI B17 05 17
Cooling Systems

SERVICE ACTION: REPLACE THE MOUNT FOR THE TRANSMISSION OIL COOLER THERMOSTAT

MODEL

G12 (7 Series)	G30 (5 Series)		
----------------	----------------	--	--

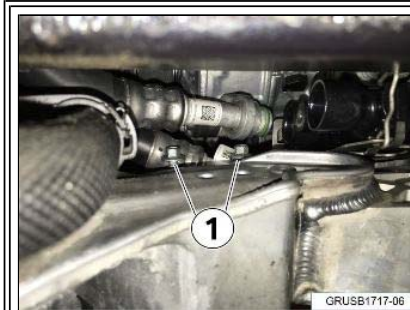
- Remove the two 8mm bolts (1) that hold the thermostat bracket to the sub-frame. Replace the bolts (PN 34 30 6 771 214) during installation and tighten to 8 Nm.

Note: The illustration shows the cooler lines removed for clarity and the bolts already loosened as a reference for the location of the bolts. **Do not remove the transmission cooler lines.**

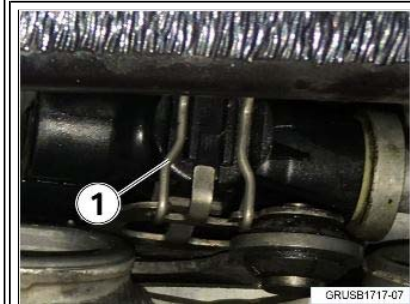
- Disconnect the clamp holding the transmission oil cooler thermostat from the holder (1).

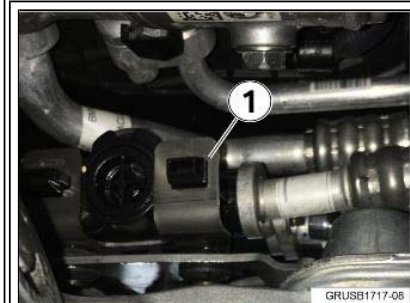
- Slide the holder out from the transmission oil cooler thermostat (1).

Install the new holder (PN 17 22 8 624 268) in reverse order.
