SI B41 03 17
Body

SERVICE ACTION: WATER INGRESS BENEATH LUGGAGE COMPARTMENT

G30 (5 Series)			
----------------	--	--	--

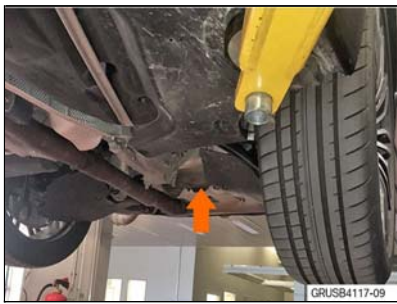
Possible water leakage into luggage compartment through PVC weld on floor. Accumulation of water in luggage compartment may not be noticed due to drain location in the vicinity.

Manufacturing process change moved PVC weld on underside of vehicle, beneath luggage compartment.

<p>GRUSB4117-09</p>	<ol style="list-style-type: none"> 1. Raise the vehicle on a lift.
	<ol style="list-style-type: none"> 2. Identify the critical area to be repaired as indicated.
