SI B52 04 17  
Seats

## BACKREST NOISES WHEN UNDER LOAD

F07 (5 Series Gran Turismo)	F10 (5 Series Sedan)
-----------------------------	----------------------

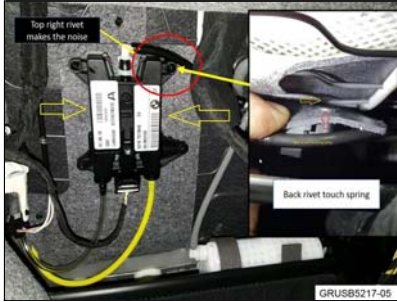
Pop noise coming from seat backrest when pressure exerted toward rear or while pulling away from a stop.

Friction between top right rivet holding lordosis (back Lumbar support) valve block and backrest cushion spring.

<ol style="list-style-type: none"> <li>1. Remove rear panel from front seat backrest according to REP 52 14 198 "Removing and installing or replacing rear panel on left or right front seat backrest".</li> <li>2. Verify that source of noise is from valve block right top rivet as shown in the photo.</li> </ol>
	<ol style="list-style-type: none"> <li>3. Attach felt (part number 51 45 2 353 024) so that it extends (as shown):             <ol style="list-style-type: none"> <li>a. behind fleece mat (covering plastic rivet)</li> <li>b. over top of valve block and</li> </ol> </li> </ol>
