Washer Fluid Reservoir Rattles While Driving on Rough Roads

This Service Information bulletin replaces SI B61 06 15 dated **March 2015**.

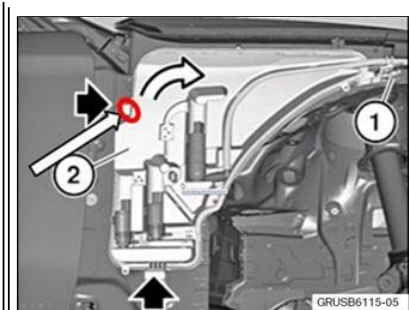
Note: Accompanying picture shown is with the passenger side fender removed for purposes of clarity.</p> <ol style="list-style-type: none"> 2. Remove the screw (1). Tightening torque = 8 Nm. 3. Pull the washer fluid reservoir (2) out of the guides (arrow) in
--	---

- the direction of the arrow.
4. Unlock and disconnect all plug connections.
 5. Unlock the filler hose and pull it off the fitting on the washer fluid reservoir.

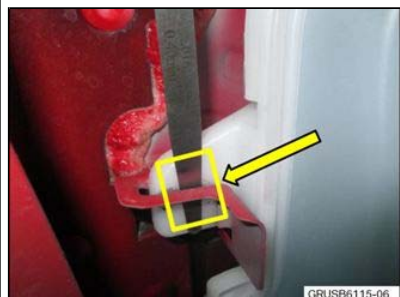
Note: The close-up picture shows a gap (0.40 mm) that exists between the plastic reservoir guide and the metal securing bracket.

The felt tape will eliminate the rattling noises coming from the metal bracket which can transmit into the glove compartment area.

6. With the reservoir removed, clean the upper guide tab with a clean cloth.
7. Prepare a piece of felt tape (80 x 60 x 1 mm) and apply it to the guide tab in the area shown.
