## N63R Map Thermostat Faults

This Service Information bulletin replaces SI B12 13 16 **dated July 2016**

| G12 (750i sedan) | With the N63R engine |

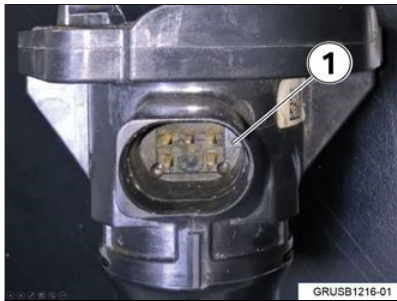
Coolant is leaking past the map thermostat electrical connector.

| | 1. Remove the connector for the map thermostat (1) and check |

| <p>GRUSB1216-01</p> | <p>for coolant.</p> <p><b>Is coolant present in the engine wiring sensor harness for cylinders 1-4?</b></p> <p>YES - replace the map sensor thermostat (PN 11 53 8 602 282) and the sensor harness (PN 12 51 8 654 414). Go to step 2.</p> <p>NO - continue diagnosis by performing the associated test plan in ISTA/D.</p> |

Replace contaminated components.

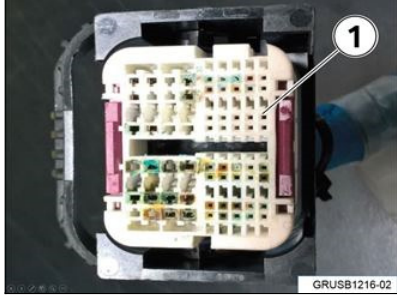
| <p>GRUSB1216-02</p> | <p>2. Check the wiring harness connector at the DME for coolant (1).</p> <p><b>Is there any coolant at the DME harness connector?</b></p> <p>YES – Continue to step 3.</p> <p>NO – Repair is complete.</p> |

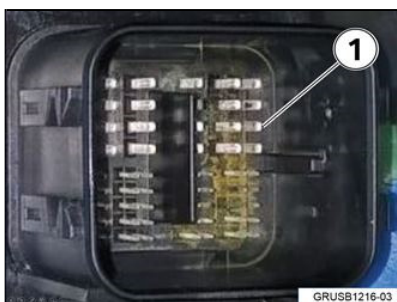
| <p>GRUSB1216-03</p> | <p>3. Check the DME and PDM connector sockets for coolant contamination (1).</p> <p><b>Is there any contamination at the electrical connectors for the DME or PDM?</b></p> <p>YES- Submit a TC case to the TC DME group for DME and PDM parts replacement approval</p> <p>NO- Repair is complete.</p> |

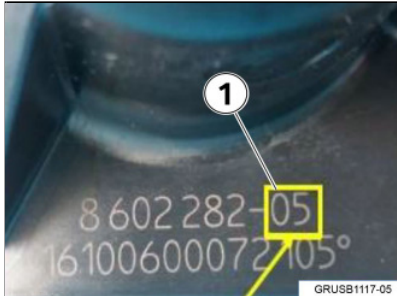
| <p>GRUSB1117-05</p> | <p><b>UPDATE!</b> Check the index number (1) on the new thermostat (PN 11 53 8 602 282). Improved service parts have an index number</p> <p><b>UPDATE!</b> “05” or later. Do not install a thermostat with an index lower than “05”.</p> |
