## KNOCKING NOISE FROM THE ENGINE COMPARTMENT

| F54 (Clubman) | F55 (Hardtop 4 door) | F56 (Hardtop 2 door) | F57 (Convertible) |

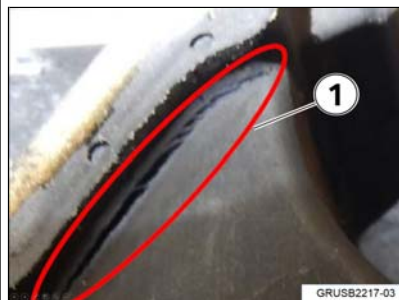
Damage to the right side engine mount. The damage may be subtle (1st picture) or obvious (2nd picture).

Inspect the right engine mount and replace if necessary.
