SI M41 01 17
Body

SERVICE ACTION: REWORK TAILGATE HINGE BOLTS

F57 (Cooper, Cooper S, JCW Convertible)			
---	--	--	--

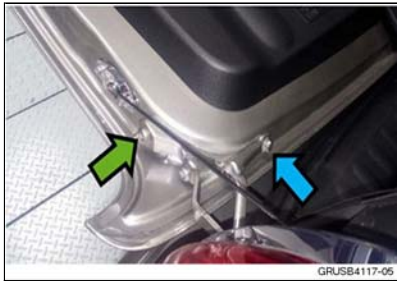
The tailgate may be hard to open or won't open.

The bolts on the tailgate hinge may not have been tightened to the required torque specification.

<ol style="list-style-type: none"> 1. Open tailgate. 2. Tighten bolts on the tail gate hinge. <ul style="list-style-type: none"> • Green arrow – M8 – 28 Nm • Blue arrow – M6 – 12 Nm 3. If the paint has been damaged due to the torquing of the bolts, restore the bolt finish with touch up paint, as needed.
---	--
