## Automatic Deactivation of Recirculation Mode

This Service Information bulletin supersedes SI M64 01 14 dated **September 2014**.

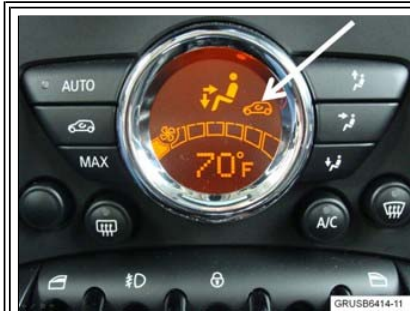
1. The recirculation display is shown when the recirculation button is pushed. It will automatically switch recirculation off after a few minutes, depending on interior and exterior temperatures, to allow fresh air to enter the cabin. This feature was added to reduce the amount of condensation and fogging on the inside of the windows.
