VARIOUS CCM (CHECK CONTROL MESSAGES) CAUSED BY SHORTED K-CAN

This Service Information bulletin supersedes SI B61 03 15 **dated May 2017**.

F22 (2 Series Coupe)	F30 (3 Series Sedan)	F32 (4 Series Coupe)	F34 (3 Series Gran Turismo)
F36 (4 Series Gran Coupe)

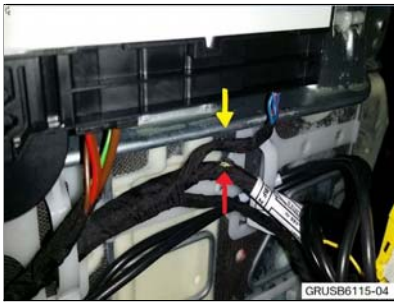
- A. Under driver or passenger front seat.

Repair and re-route shorted harness to prevent a repeat visit.

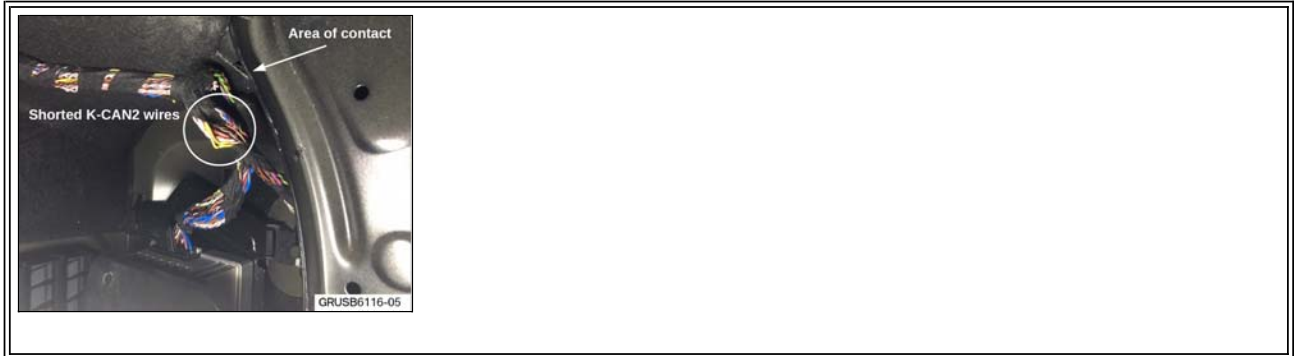
B. Between the left side trunk trim panel and the body

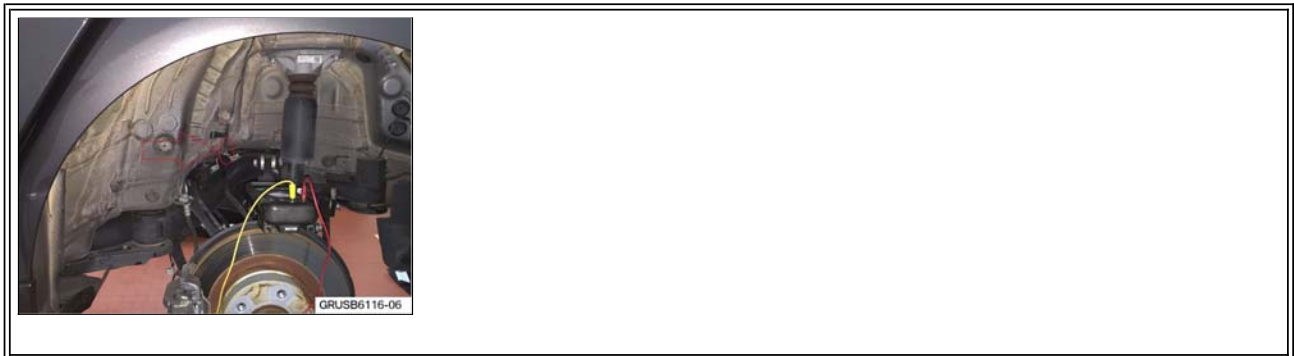
C. On the body in the left rear wheel well area

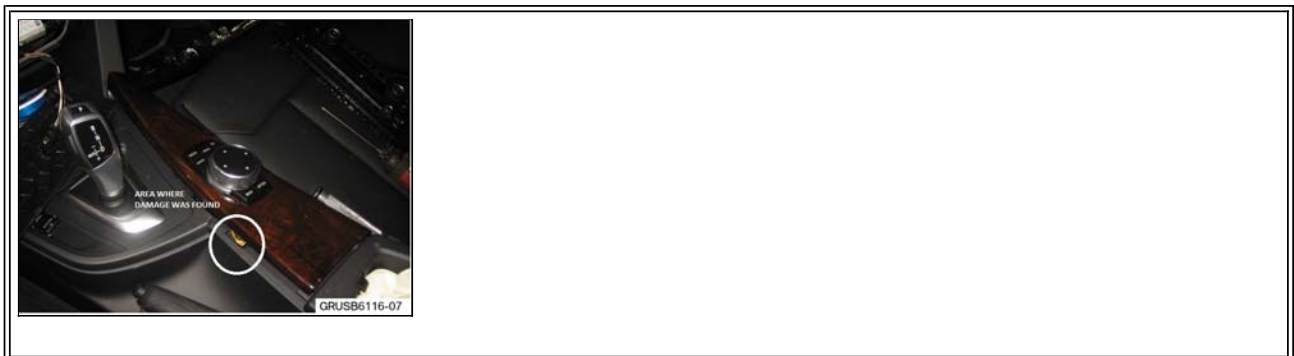
D. Under the center console trim (also check near controller)

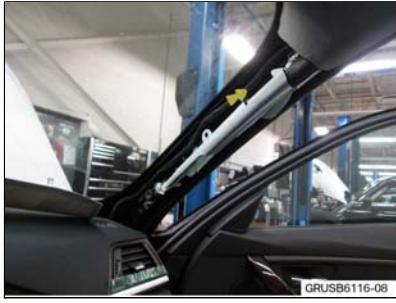
E. Short in A-Pillar behind trim (clip pinching harness)

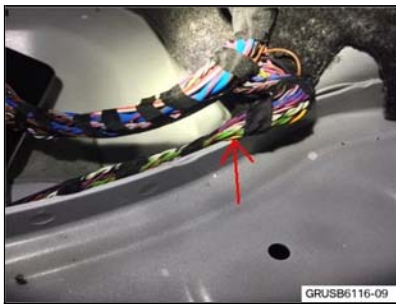
F. Short under left rear inner trunk area

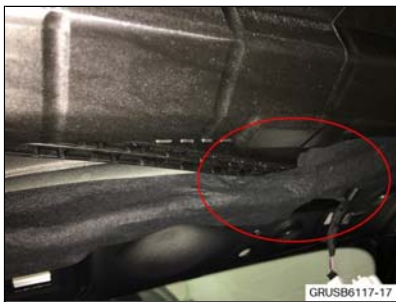
G. Check to the right of the passenger front vanity light above headliner.

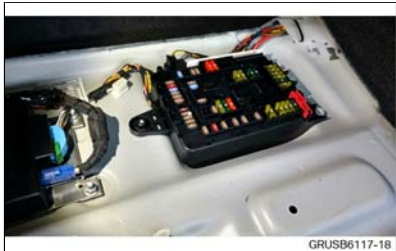
UPDATE! H. Check the area under the rear fuse box in the RH side of the trunk (thanks to Ivan Rodriguez of Crevier BMW)

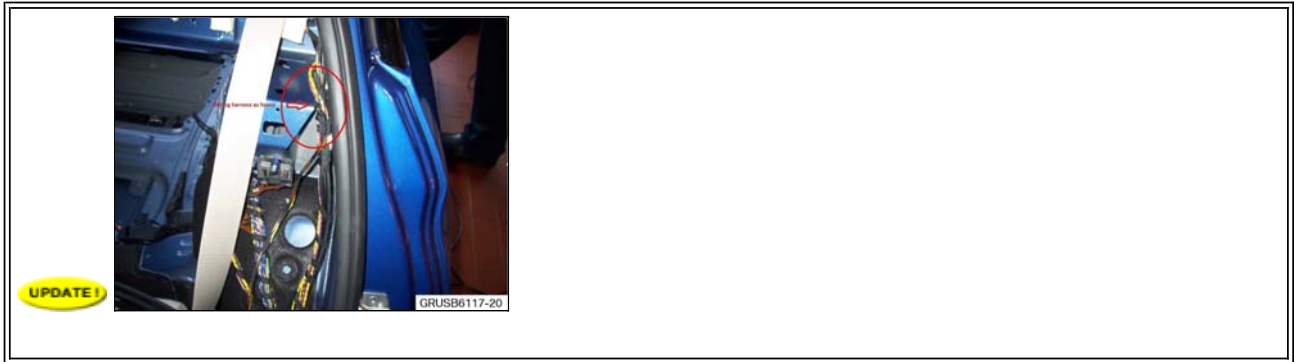
Shorted K-CAN2 wires on the rear seat bolster bracket

1. Check the wiring at the area of the rear seat bolster bracket as per the picture below.

2. Repair short.
3. Reinstall all components, ensuring routing prevents future wire damage.
