SI B62 11 17
Instruments

INSTRUMENT CLUSTER HAZES OVER

I01 (i3 & i3 REx)			
-------------------	--	--	--

Produced from 1/1/17 through 7/31/17

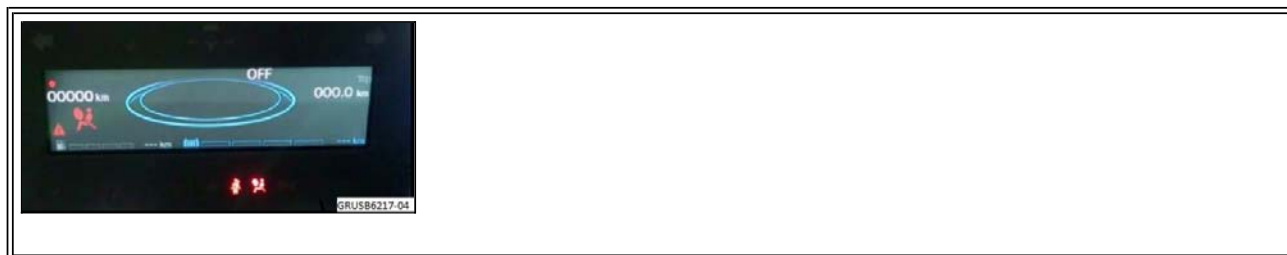
Customer notices a gray haze (shown below) on the instrument cluster face after:

- Instrument cluster was cleaned with a microfiber cloth.
- A film is removed from instrument cluster face after repair.

Excessive electrostatic charging of the instrument cluster **caused by faulty grounding inside the cluster** between the circuit board and the display.

1. Allow vehicle to sit for ten minutes.

Did the cluster graying dissipate?

YES- Inform the customer of the possibility of this graying and its usual dissipation.

NO – go to next step

2. Perform diagnosis with the latest version of ISTA.

Does ISTA diagnose any issues with the instrument cluster?

YES- continue with ISTA diagnostic suggestions.

NO – Replace the instrument cluster
