AIR CONDITIONING COOLING IS INSUFFICIENT

MODEL

F48 (X1)

With option code SA 530 air conditioning or SA 534 Automatic air conditioning Produced from 2/1/2016 to 9/30/2016.

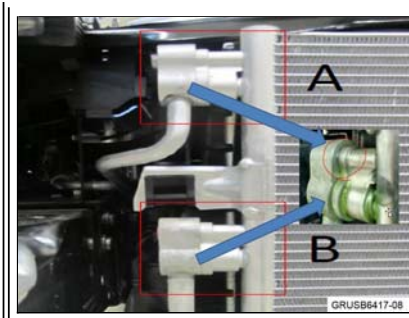
| | <ul style="list-style-type: none">• Disassemble the flange joints (A and B as shown). |

- Discard O-ring seals
- Clean flange joint with lint-free cloth.
- Inspect sealing surfaces of flange joint.

- Replace seals.
- Reassemble and retest the system.

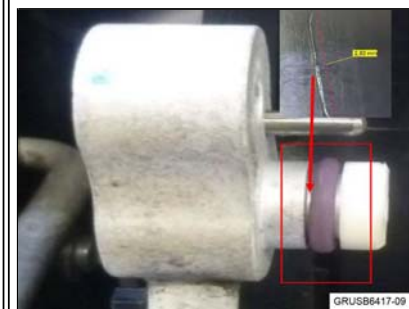
Are there deep scratches or material missing from line O-ring surface (see picture)?

YES- Replace the affected pressure line. Go to next step.
