SNAP-IN ADAPTER IS ERRONEOUSLY LISTED AS MEDIA/RADIO EQUIPMENT

F48 (X1)			
----------	--	--	--

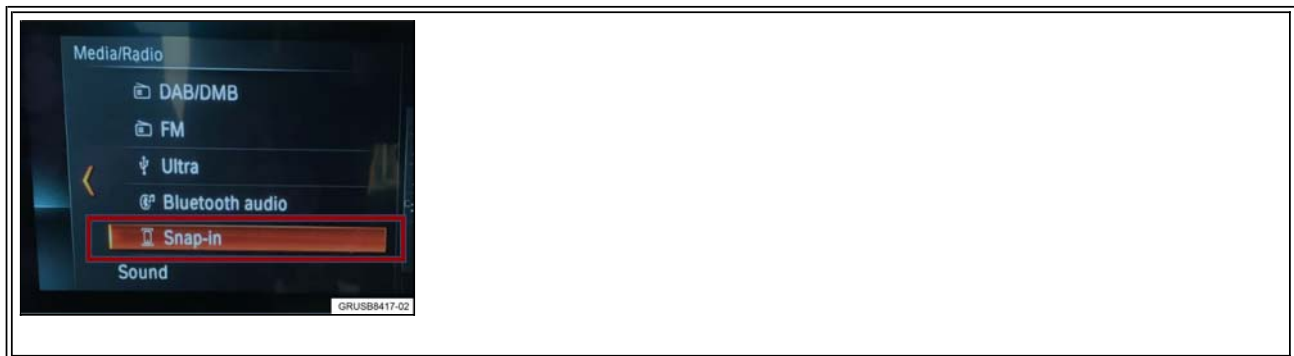
The Snap-In Adapter is displayed as installed Media/Radio equipment by the Head Unit although it is not (obsolete as of 7/2017).

Head unit software error.

Reprogram and code vehicle.

1. Perform diagnosis with the latest version of ISTA.
2. Program the vehicle using ISTA 4.06.3x or higher.
