SI M51 04 17  
Body Equipment

## SERVICE ACTION: HOOD RELEASE BOWDEN CABLE POSITIONING

| F60 (Cooper, Cooper S, JCW Countryman) | | | |

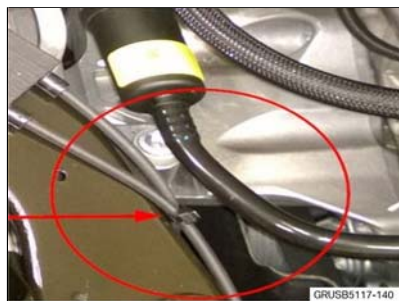
Tank ventilation line and/or hood release Bowden cable may have been damaged.

The hood release Bowden cable is unsecured and in contact with the tank ventilation line.

| | <ol style="list-style-type: none"> <li>2. Reposition the hood-release Bowden cable away from the tank ventilation line.</li> </ol> |

3. Secure both hood-release Bowden cables to the body with a wire tie as shown.
