SI M51 16 16
Body

September 2017
Technical Service

CAVITY PROTECTION WAX LEAKING OUT OF HOOD

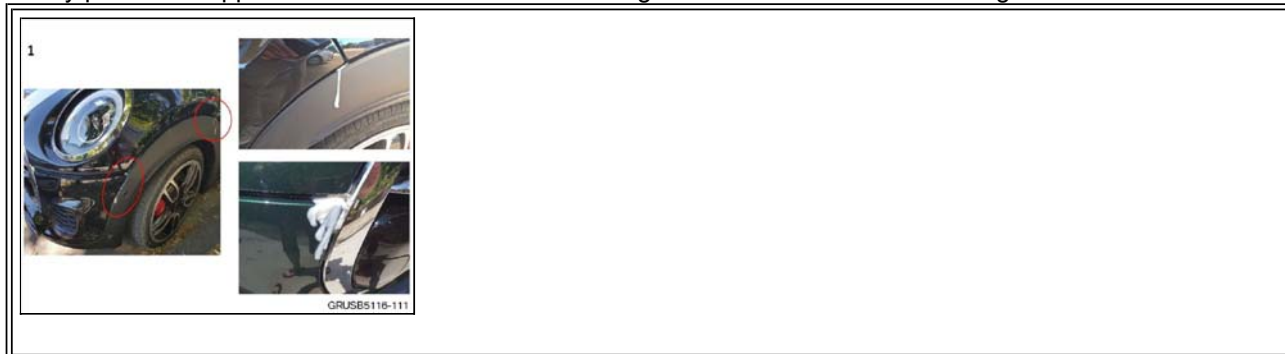
Cavity protection applied to underside of hood is leaking out onto wheel arch trim and grille.

Improper application of Cavity Protection Wax

Remove current cavity protection and reapply.
