Subject: Recall R89716

Recall R89716: Replace 3rd Row Passengers Side Seatbelt Retractor Model Year 2017, Model XC90 with 7 Seats

Recall R89716: Replace 3rd Row Passengers Side Seatbelt Retractor

Title	Seat belt retractor, rear	Page	1 (9)
Action	Replacement	Operation number:	97195-2

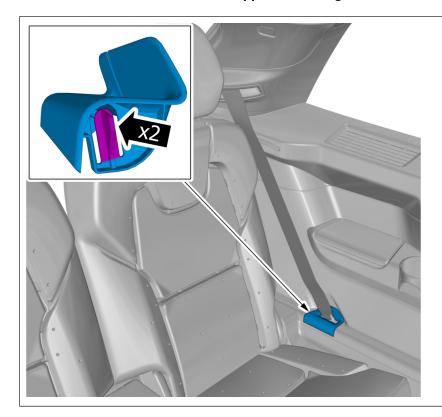
Right-hand side
Remove the marked part.

Special Tool: T9814071, Interior trim remover

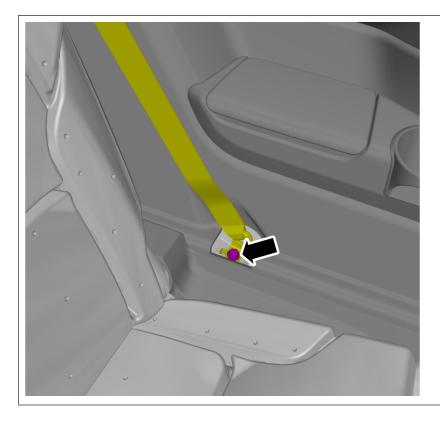
Right-hand side Remove the screw.

Safety belt lower anchor to body (rear) , 40 \mbox{Nm}

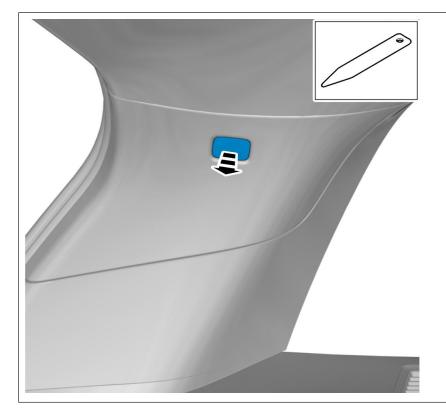
Right-hand side Remove the marked part.

Special Tool: T9814071, Interior trim remover

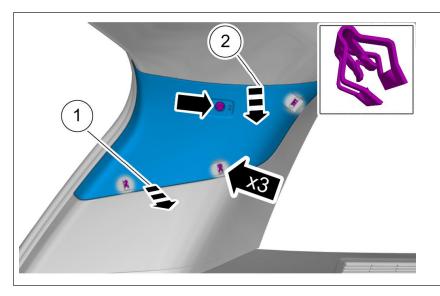
- 2 . Remove the screw.
- 3 . Remove the panel.

Panel, to D-Pillar, 4.5 Nm

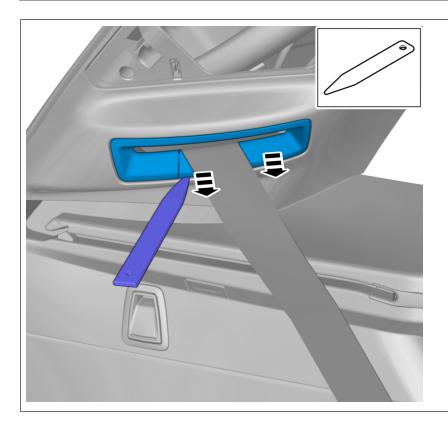
Right-hand side
Remove the marked part.

Special Tool: T9814071, Interior trim remover

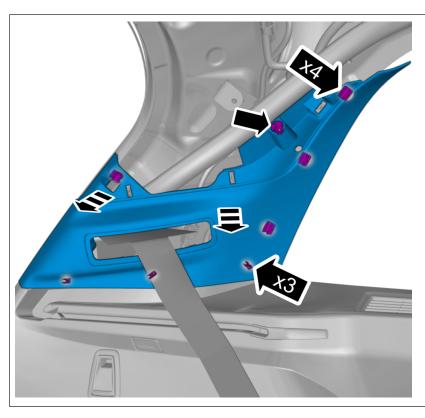
Right-hand side Remove the nut. Remove the marked part.

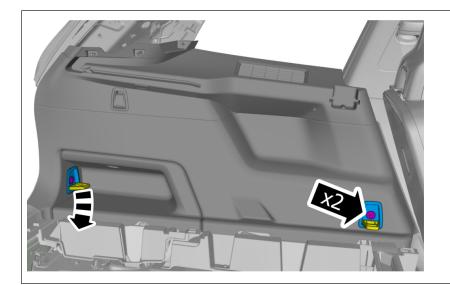
Right-hand side Remove the screws.

Cargo anchor, to body, 13 Nm

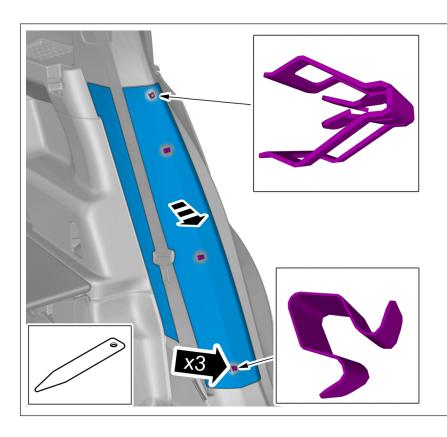
Right-hand side Remove the panel.

Special Tool: T9814071, Interior trim remover

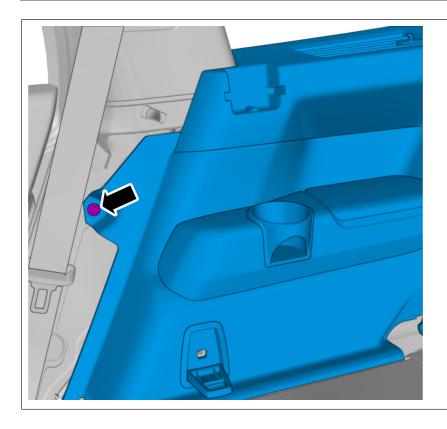
Right-hand side Remove the screw.

M5 , $5\ Nm$

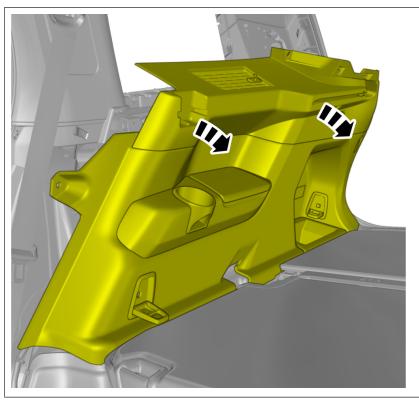
Right-hand side Fold marked part to one side.

Disconnect connector ignition cable, refer to: Cleaning, Inspection and Adjustment

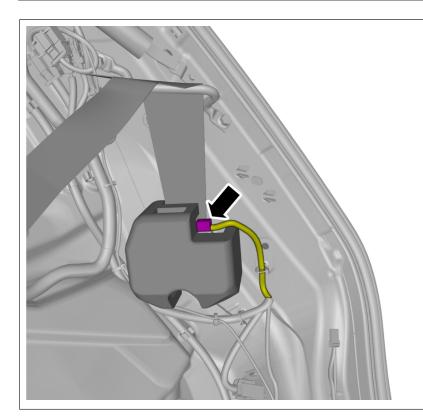
Right-hand side
Disconnect the connector.

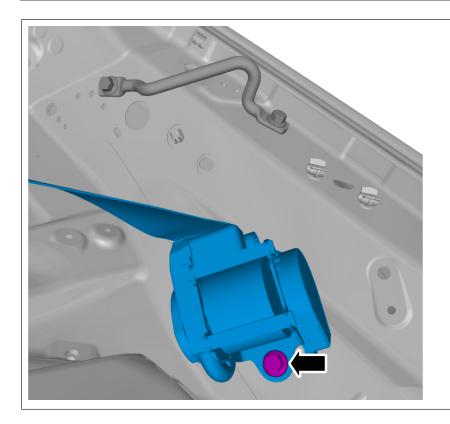
Right-hand side Remove the screw. Remove the marked part.

Safety belt retractor rear to body, 40 Nm
