Technical Journal

Seat hard to push back, second row seat (7 seater)

REF NO: TJ 32025.4.0	ISSUING DEPARTMENT: Technical Service	CAR MARKET: United States and Canada	
PARTNER: 3 US 7510 Volvo Car USA		ISSUE DATE: 2017-09-26	STATUS DATE: 2017-09-27
FUNC GROUP: 8531	FUNC DESC: Rear seat, complete	Page 1 of 6

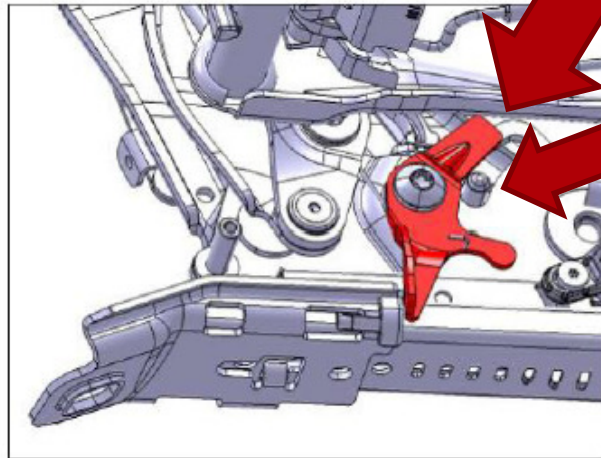
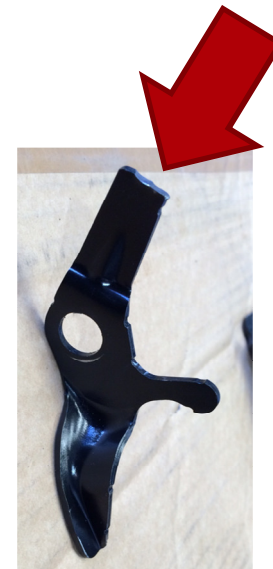
Issue:

- Outer seat in 2:nd row is hard to move back after entrance to 3:rd row.
- Backrest folds back too early (before seat is slided back).

Reason:

Stopping edge of rebound bracket wear against the stop screw. This wear prevents it from releasing.

Solution:

- Replace the rebound bracket.
