POWERTRAIN FAULTS DUE TO CHAFING OF ENGINE WIRING HARNESS

F15 (X5 3.5d)

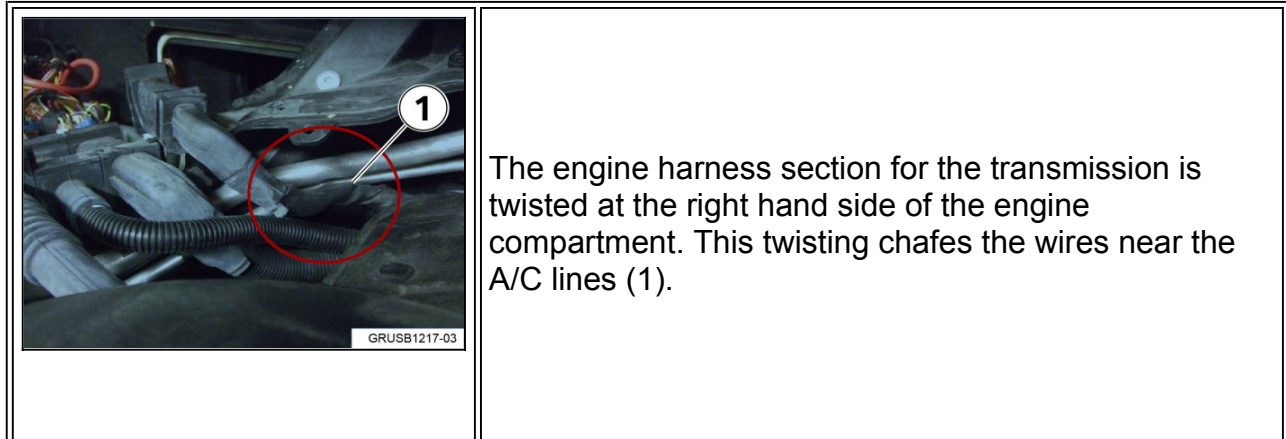
CAUSE

- Check the harness for twisting and chafing at the A/C lines. If one wire is damaged, repair that wire (refer to Repair Instruction 61 13 ... Butt connector for repairing a plug connection). After repairing the wire, disconnect the harness at the DDE and untwist the harness. Ensure no contact with the A/C lines.
- If more than one wire is damaged, replace the engine wiring harness for the transmission. Ensure the new harness isn't twisted at the A/C lines when installing.
- If there is no chafing of the harness follow the appropriate test plan in ISTA to diagnose the fault code(s) stored.
