WINDOW FRAME TRIM OF FRONT DOOR IS DISPLACED

F10 (5 Series)

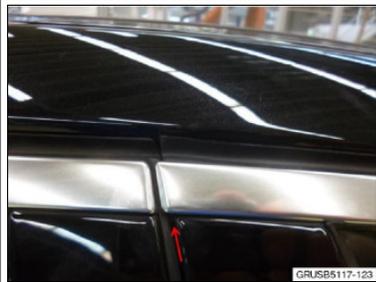
Front window frame trim is offset toward "B" pillar (as shown).

Replace one or both window frame trim panels, if damaged.

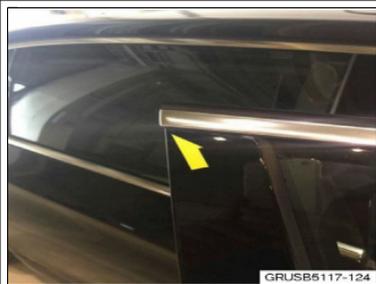
Frame trim damage may be caused by trim overlap.
