## RATTLE IN THE “REPLACEMENT” DOOR ASSEMBLY

G12 (7 Series)

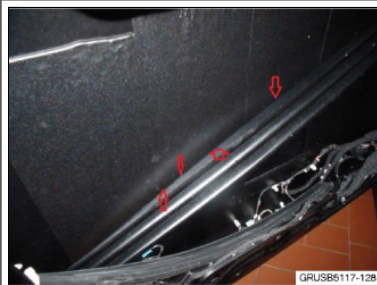
The replacement door assembly is “missing” the adhesive in the door shell between the side impact protection and outer skin.

1. After consulting the vehicle maintenance history, verify the door has been replaced and is not an original factory-installed door.
2. According to the repair procedure, remove the door module carrier for the affected door: Refer to Repair Instructions – “51 33 070 Replace left front door module carrier”, or “51 33 072 Replace right front door module carrier”,
3. Verify the adhesive is missing where shown above.
4. Apply seam sealer (part # 83 42 2 409 985) where shown below.

Door assembly replacement is **not** necessary. To repair, install spreadable seam sealer at the indicated location to eliminate the vibration.
