UPDATE! **VOLUNTARY EMISSIONS RECALL CAMPAIGN 17E-A01:
CHECK CHARGING OF THE HIGH VOLTAGE BATTERY**

MODEL

F15 PHEV (X5)

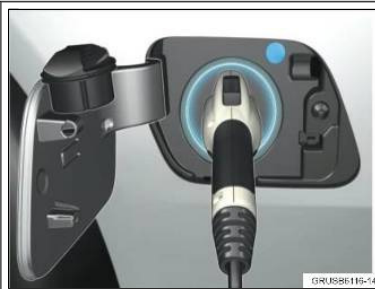
2. Connect Level 2 (220V) charging cable to the vehicle.

Wait 15 seconds until the “Charging Active” blue light is illuminated.

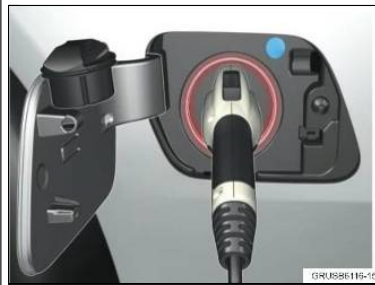
3. **Repeat this step 20 times. Was “Charging Active” indicated in every (all 20) charging cycle attempt?**

4. If the charging port indicator light flashes red (“Charging error”), connect vehicle to ISTA diagnostics and read vehicle’s fault memory.

Is KLE fault code 21E64A (Charging electronics, internal fault step down converter voltage sensor measured value outside set-point) stored?

5. The KLE charging electronics module needs to be replaced. Follow the ISTA RA61 44 502 repair instruction (Removing and installing/replacing the KLE)
