## STEERING WHEEL BUTTONS DO NOT FUNCTION RELIABLY

F22 (2 Series Coupe)	F23 (2 Series Convertible)	F30 (3 Series Sedan)	F31 (3 Series Sport Wagon)
F32 (4 Series Coupe)	F33 (4 Series Convertible)	F34 (3 Series Gran Turismo)	F36 (4 Series Gran Coupe)
F80 (M3 Sedan)	F82 (M4 Coupe)	F83 (M4 Convertible)

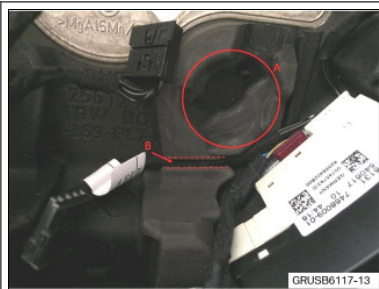
Note: Be certain to correctly route the wiring for the steering wheel connecting line as shown below

1. 1. Keep the area of the airbag counter piece area (A) clear to avoid the risk of crushing the harness. Be certain to use the routing guides (B) to run the cables.

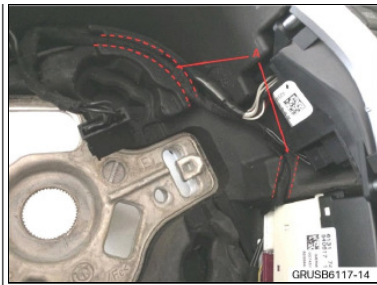
2. Be certain to use the routing guides (A) to run the cables.

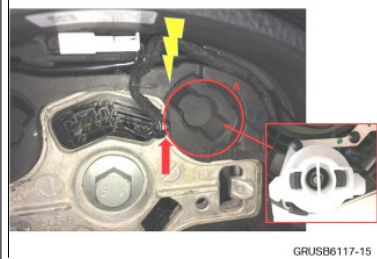
3. Keep the area of the airbag counter piece (A) clear to avoid the risk of crushing the harness.

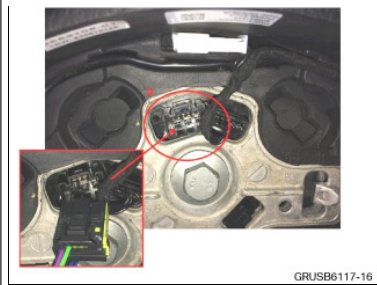
4. Keep the area of the cable connection clear (A).
