AIRBAG WARNING LAMP ILLUMINATED

This Service Information bulletin Replaces SI B65 18 16 **dated September 2016**.

I01 (i3)

Vehicles from Start of Production (SOP) to April 30, 2016
----------	---

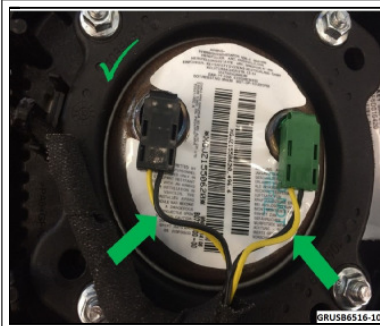
Correct tension free routing

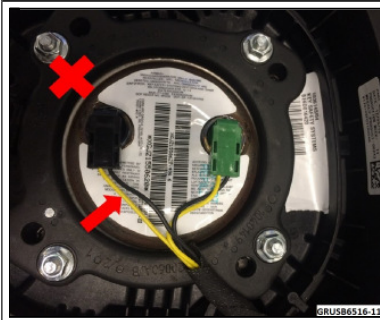
Tension caused by harness cable tie on short jumper harness located between steering column slip ring and driver's airbag creates excess resistance.

Incorrect routing. The yellow wire is under tension.

UPDATE! Make sure harness to air bag is not routed under tension. See pictures below.
