## LOCKING FUNCTION INOPERATIVE FROM THE HANDLE, ON VEHICLES WITH COMFORT ACCESS

G30 (5 Series Sedan)	With option code 322 Comfort Access	Produced through January 02, 2017
----------------------	-------------------------------------	-----------------------------------

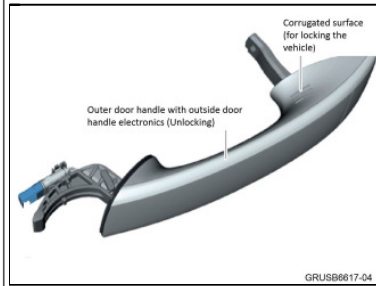
3.

Activation failure is expected if both the Close and Open activation areas are touched simultaneously- Open is on inside middle of handle, Close is on top front of handle.
--	---
