SI M51 16 16  
Body

## CAVITY PROTECTION WAX LEAKING OUT OF HOOD

F56 (Cooper, Cooper S Hardtop 2 door)

F57 (Cooper, Cooper S Convertible)

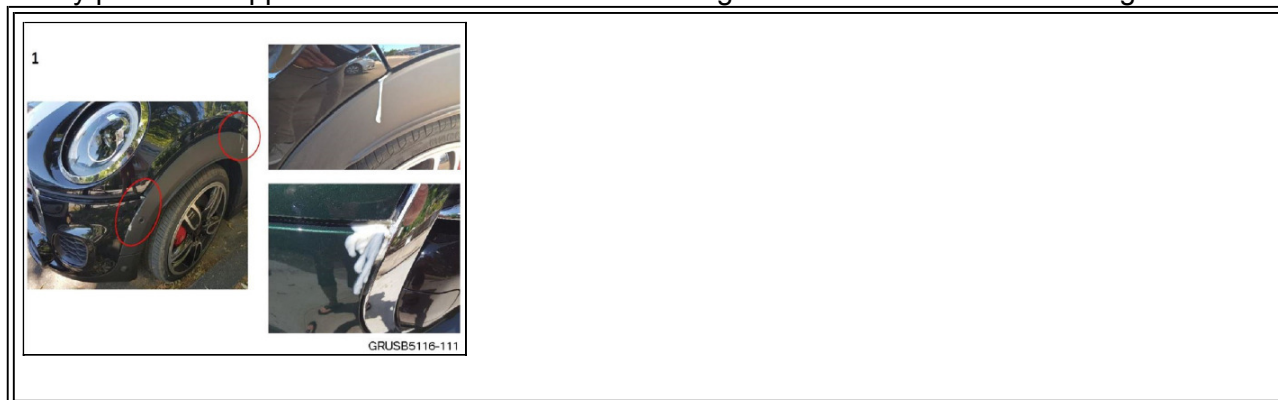
Cavity protection applied to underside of hood is leaking out onto wheel arch trim and grille.

Improper application of Cavity Protection Wax

Remove current cavity protection and reapply.
