## HORN DOES NOT WORK

This Service Information bulletin supersedes SI M61 02 16 **dated September 2016**.

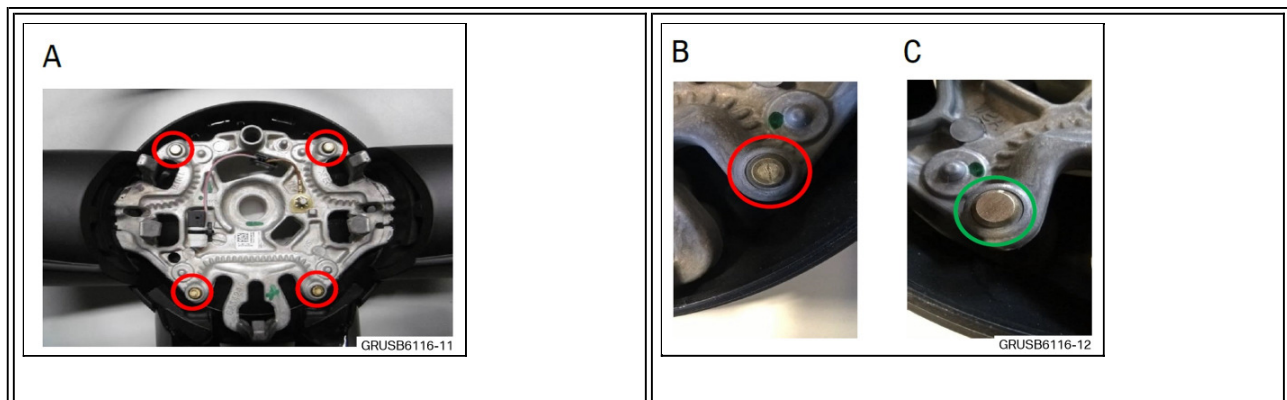
- Only F54, F55, F56, F57: Dissimilar metal corrosion between horn switch contacts and airbag unit.

1. Remove the air bag unit in accordance with REP 32 34 020 "Remove and refit/replace the air bag unit."
2. Remove corrosion from all four contacts (see Figure A) using sandpaper of 400 grit or higher (see Figure B) until contacts are shiny (see Figure C). It is not necessary to clean the wire for the horn at the airbag unit.

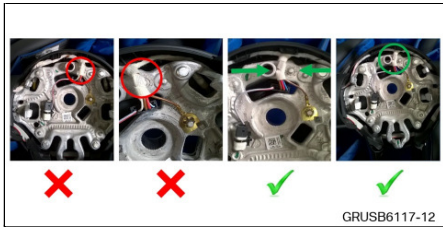
All models: routing of the connecting wires on the steering wheel incorrect

1. For F60 remove the air bag unit in accordance with REP 32 34 020 "Remove and refit/replace the air bag unit." For all other vehicles the air bag is already removed.
2. Check the routing of the connecting line as shown below. If the wires are positioned over the protrusion as highlighted in red, move the wires to the left of the protrusion as shown highlighted in green.
