****Technical Campaign****

Shift Assistant

**R 1200 GS (K50, 0A11),
 R 1200 GS Adventure (K51, 0A12),
 R 1200 RT (K52, 0A13),
 R 1200 RS (K54, 0A15)**

Service Information No. SI 23 001 17

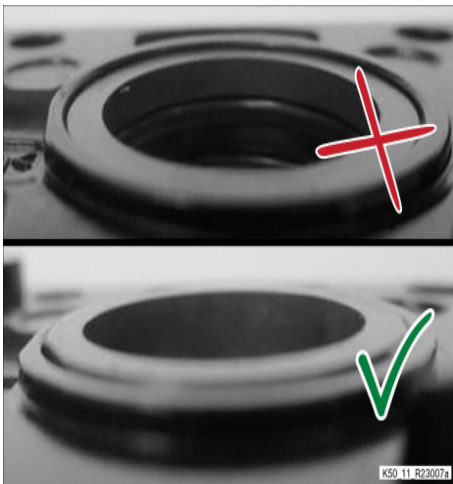
Figure 1:

During the course of the quality analysis carried out by BMW Motorrad, it has been determined that for the R 1200 models with the gearshift assistant (SA X222A) OE, a few faulty gearshift assistants have been installed in the production period from 09/02/2016 to 09/05/2016. Over the service life of the vehicle, there can be impairment of functions up to a loss of function of the gearshift assistants.

- Top: Gearshift assistant with incorrectly installed bearing
- Bottom: Trouble-free gearshift assistant

The affected vehicles must be converted **before delivery** or at the next service visit.

Renew the gearshift assistant as described in labor operation 23 14 006.
