WHEEL COVER PILOT PROGRAM

F30 (3 Series Sedan)	F31 (3 Series Sports Wagon)	F32 (4 Series Coupe)	F33 (4 Series Convertible)
F34 (3 Series GT)	F36 (4 Series Gran Coupe)

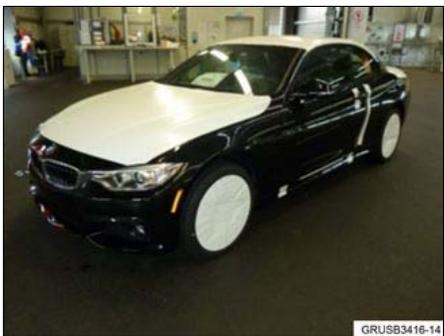
Starting January 2017 and through March 2017, “300” (F3x) 3 Series and 4 Series vehicles produced at the Munich plant will be additionally equipped with wheel mounted protection covers (Bodyguard®, a white-colored mild adhesive film) as shown below.
