BLINDSPOT DETECTION WARNING: FALSE ACTIVATION

G12 (7 Series Sedan)			
----------------------	--	--	--

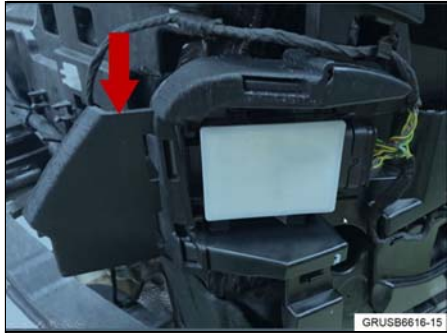
This sensor shield prevents the incorrect scattering of the radar signals at the rear bumper, which causes false warnings.

2. Remove the rear bumper panel following repair instructions REP 5112156 – removing and installing rear bumper panel.
3. Install the sensor shield as shown in the picture.
