MIL "ON" DTC P2610

Service Category Engine/Hybrid System

Section Engine Control

| YEAR(S) | MODEL(S) | ADDITIONAL INFORMATION |
|---|---|---|
| 2015 | iQ | |

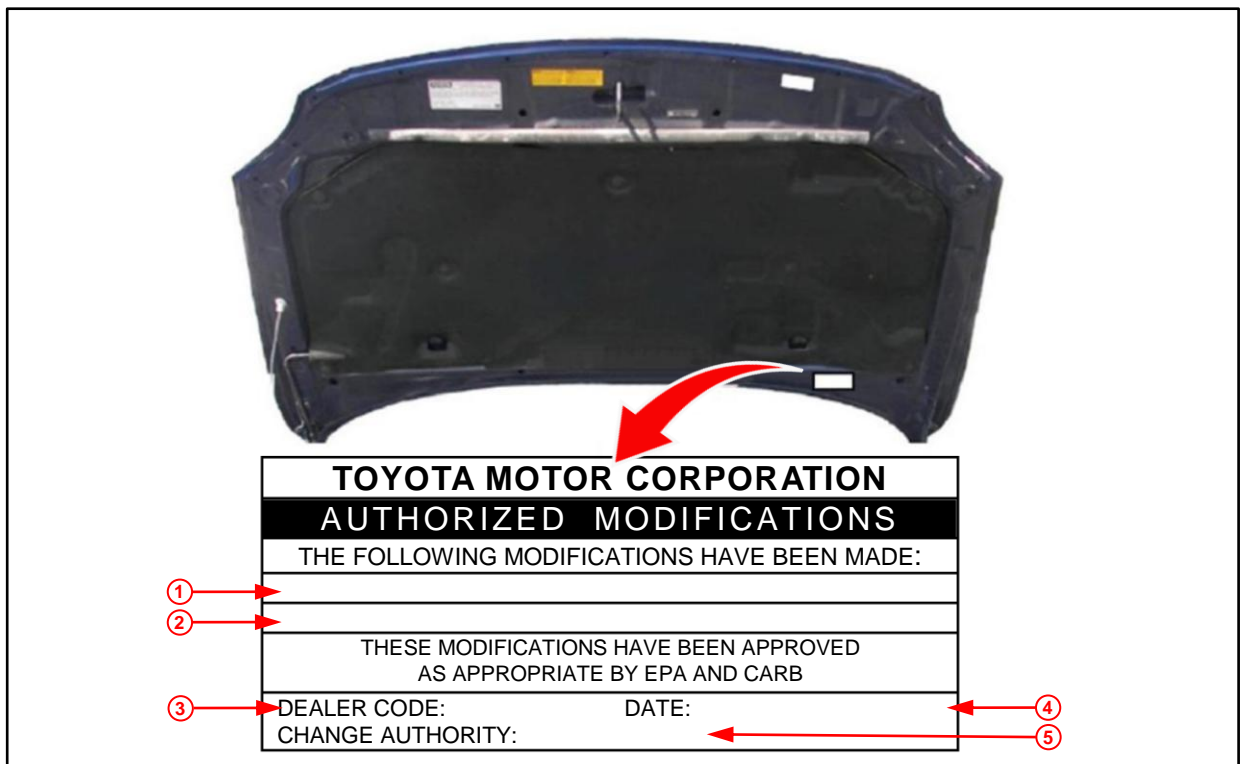
Figure 1. Location of Authorized Modifications Label for 2015 iQ

2. Check for the Authorized Modifications Label affixed to the vehicle in the location shown below. Confirm if the ECM (PCM) calibration has been updated.

- Prepare and install the Authorized Modifications Label.
 - Using a permanent marker, enter the following information on the label:
 - ECM (PCM) part number [Refer to the **Parts Information** section for the **NEW PART NUMBER**]
 - Calibration ID(s) [Refer to the **Calibration Information** section for the **NEW CALIBRATION ID**]
 - Dealer Code
 - Repair Date
 - Change Authority [**This bulletin number**]
 - Install the Authorized Modifications Label to the vehicle at the location shown in Figure 1. The Authorized Modifications Label is available through the MDC, P/N 00451-00001-LBL.
- Test drive the vehicle to confirm proper vehicle operation.
