Service Category	Vehicle Exterior		
Section	Door/Hatch	Market USA	Scion Supports ASE Certification

YEAR(S)	MODEL(S)	ADDITIONAL INFORMATION	
2016	iA

Introduction

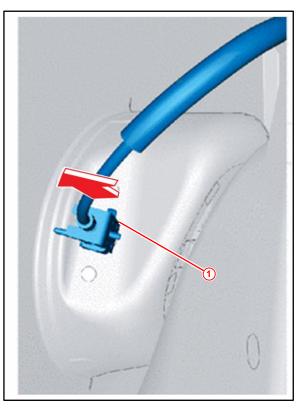
Some 2016 model year iA vehicles may exhibit a condition where the fuel door will NOT open due to a detached cable from the retainer when pulling the release lever. This condition may have been caused by incorrect assembly during manufacturing. Follow the procedure in this bulletin to address this condition.

5. Remove the fuel filler lid opener in the direction of the arrow.
