Technical Service Bulletin

19 Heating output insufficient (DTC B10D004 and/or B11D501)

19 17 90 2047114/4 September 12, 2017. Supersedes Technical Service Bulletin Group 19 number 17-85 dated April 4, 2017 for reasons listed below.

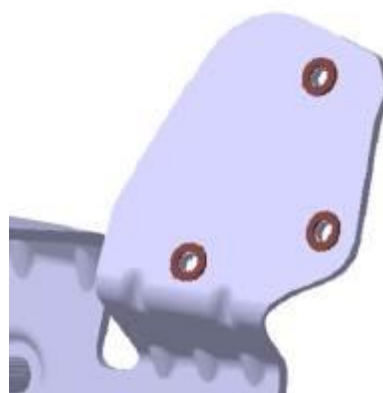
Figure 1. Washers installed.

Replace the V50 coolant recirculation pump, use the washers if pump is mounted with screws to the bracket as shown (some models have rubber covered metal band instead):

- N 011 523 21 (3x)

To ensure about 1mm distance between the V50 coolant recirculation pump and its bracket (Figure 1 and 2):

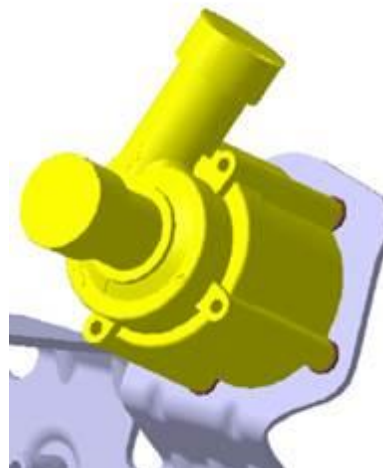
Figure 2. Pump mounted.
