#### 19 Coolant level warning light on, coolant marks on coolant pump - 4.0 TFSI

19 17 91 2048936/1 September 20, 2017.

Model(s)	Year	VIN Range	Vehicle-Specific Equipment
S6, RS 6, and S7	2013 - 2018	All	4.0 TFSI
RS 6+, RS 7+	2016 - 2018	All	4.0 TFSI
RS 7	2014 - 2018	All	4.0 TFSI
A8, S8	2013 - 2017	All	4.0 TFSI
S8+	2016 - 2017	All	4.0 TFSI

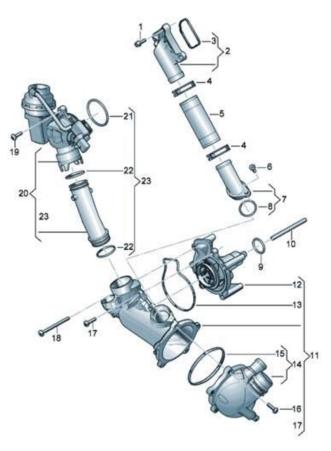
There are coolant marks in the area of the coolant pump housing (Figure 1, position 12), the coolant connector union (Figure 1, position 7) or the thermostat housing (Figure 1, position 14). After cleaning the coolant marks and performing another leakage test there are **fresh** coolant marks on the coolant pump drive (Figure 2 through Figure 6).

Figure 1. View position complete water pump assembly (rear view).

- 1. Fully complete the attached worksheet and attach it to the repair order.
- 2. Remove the coolant marks and bleed the cooling system according to the repair manual. Then check the cooling system for leaks according to the repair manual:
  - If there is no new leak visible on the coolant pump, do not perform any further repairs.
- 3. If a new coolant leak is detected and can be assigned to a component, take a photo of the **renewed** leak and attach it to the repair order.
- 4. If there is a coolant leak in the area of the coolant connector union a replacement of the O- ring only (Figure 1, position 8) is sufficient.

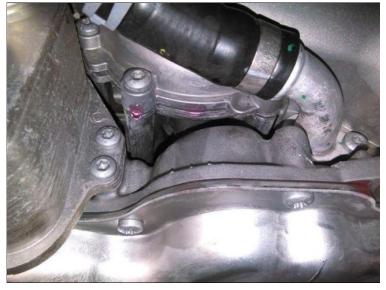
Figure 4. Coolant marks on flange of thermostat housing.

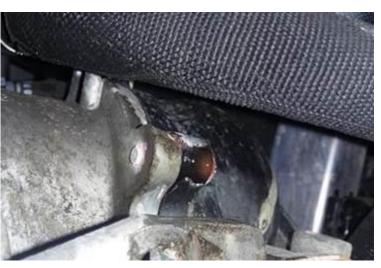
Figure 5. Coolant marks on coolant connector union.

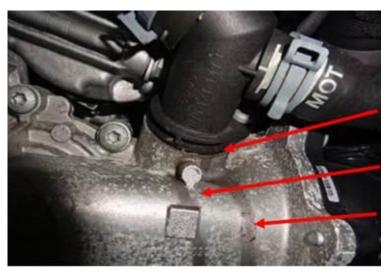
Figure 6. Areas where coolant marks can be found.

The coolant pump housing is sealed off with a slip ring seal to the input shaft. To prevent the seal from drying up, a minor coolant leak is necessary to lubricate the seal.

If coolant marks are detected in the area of the coolant pump housing during a service and there is no customer concern about coolant level/loss, a replacement of the coolant pump housing is not allowed.
