Technical Service Bulletin

64 Creaking noises from front or rear windshield area

64 17 43 2046397/2 September 19, 2017. Supersedes Technical Service Bulletin Group 64 number 16-39 dated December 26, 2016 for reasons listed below.

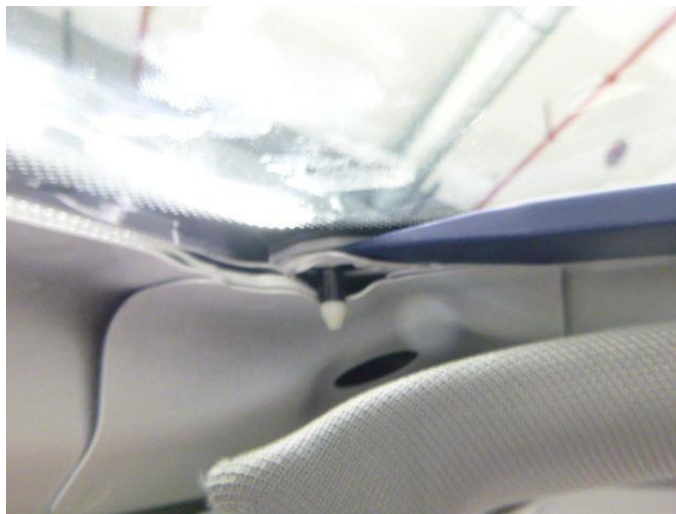
Creaking noises in the front windshield area on the upper A pillar or on the upper corners of the rear windshield. The noise can occur on the left or right sides of the front and rear windshield.

The guide pins on the upper end of the windscreen and rear window, which are needed in production for positioning, make noises when scraping on the body.

Figure 1. Increase the distance between plastic pin and metal lug.

1. If the noise occurs on the windshield in the A pillar area, remove the sun visor and the A pillar trim according to the repair manual. Once you can see the plastic pin and the metal lug which is in the plastic pin as shown in the illustration. Increase the distance between plastic pin and metal lug with a plastic wedge by bending down the metal lug by 1-2mm (Figure 1).

2. After the repair, check whether the noise is still there by pressing down on the windshield near the guide pin. If the noise is still there, you can increase the distance between plastic pin and metal lug a little more.
