# Technical Service Bulletin

## 70 Noises from headliner/sunroof area

70 17 64 2044417/6 September 20, 2017. Supersedes Technical Service Bulletin Group 70 number 17-61 dated May 30, 2017 for reasons listed below.

Model(s)	Year	VIN Range	Vehicle-Specific Equipment
A4 allroad	2017 - 2018	All	Not Applicable
Q7	2017 - 2018	All	Not Applicable

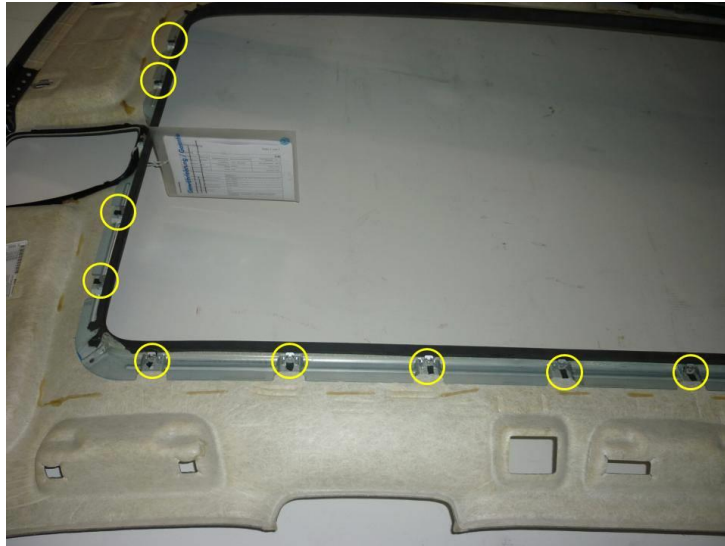
**Figure 1.** Location of the headliner to sunroof frame clips.

2. Remove the headliner. The clips shown in the illustration will need webbing adhesive tape (D 004350A2) (Figure 1).

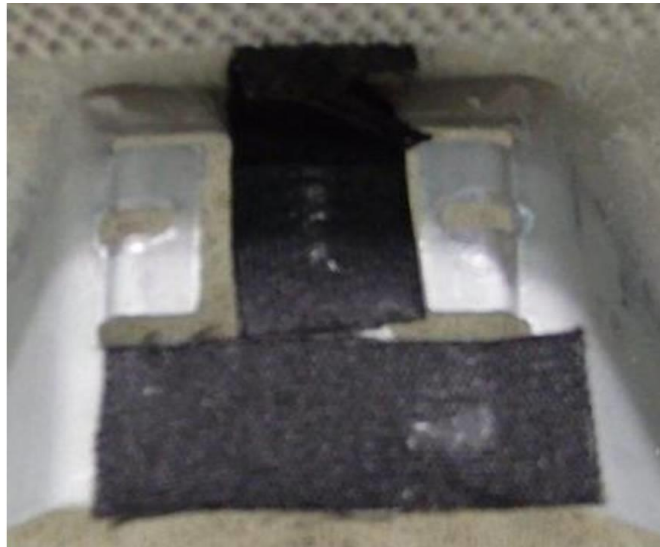
**Figure 2.** Location of the webbing adhesive tape application.

3. Remove the clips and apply the webbing adhesive tape underneath them, as shown (Figure 2).

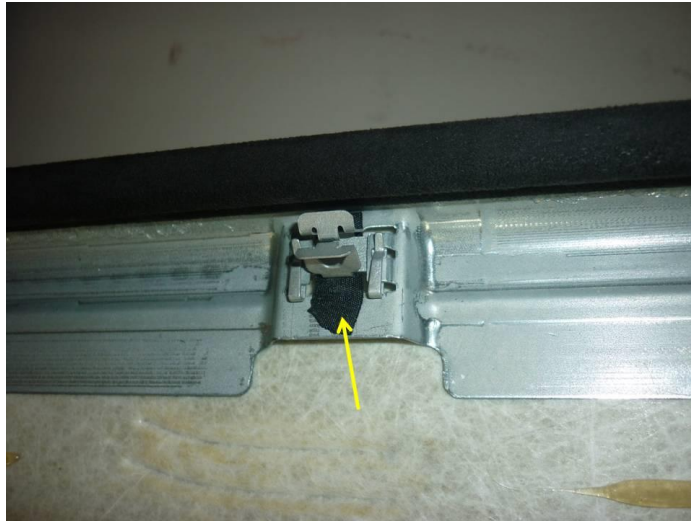
**Figure 3.** Clips reinstalled.

4. Reinstall the clips (Figure 3).

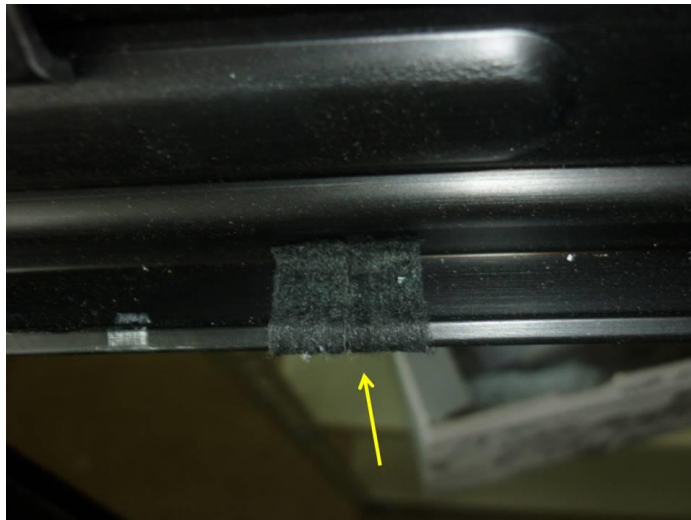
**Figure 4.** Application area on sunroof frame area of clip engagement.

5. Apply webbing adhesive tape to the sunroof frame lip at each clipping point (Figure 4).

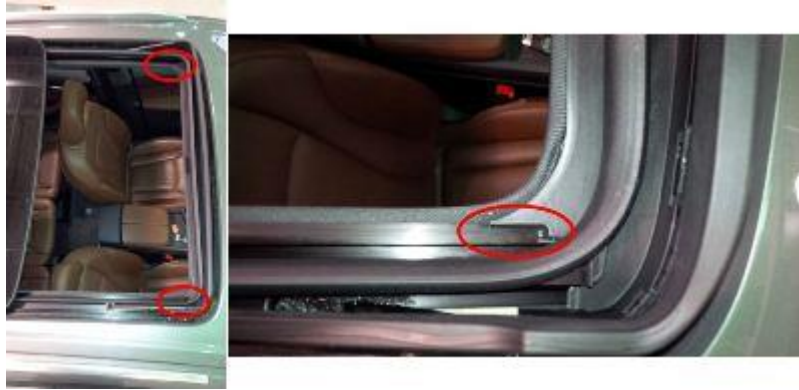
6. There are two additional points of contact at the front sunroof frame plates that could be a source for noise (Figure 5).

**Figure 5.** Areas of the sunroof frame to be isolated with webbing adhesive tape.

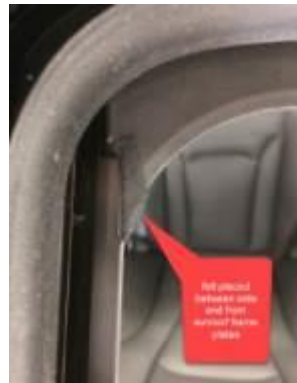
**Figure 6.** Webbing adhesive tape applied between the side and front sunroof frame plates.

7. Apply webbing adhesive tape between the sections of the sunroof frame plates on both the right and left sides as shown in the illustration (Figure 6).
