Technical Service Bulletin

87 Faint noise heard in cabin from air conditioning circuit

87 17 82 2044717/5 September 20, 2017. Supersedes Technical Service Bulletin Group 87 number 17-81 dated August 16, 2017 for reasons listed below.

Model(s)	Year	VIN Range	Vehicle-Specific Equipment
A6, A7	2012 - 2015	All	2.0L or 3.0L gas engine

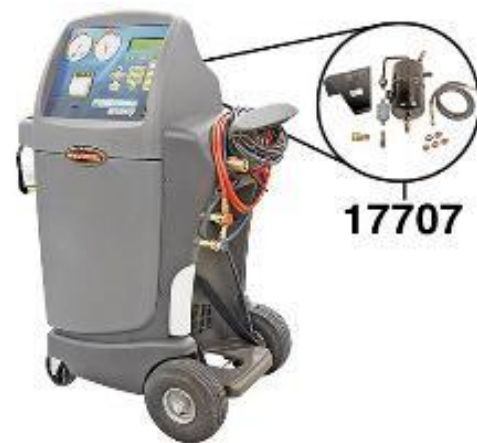
Figure 1. A/C flushing unit.

1. Perform a complete recovery and flush of the air conditioning refrigerant circuit (Figure 1 and Figure 2).

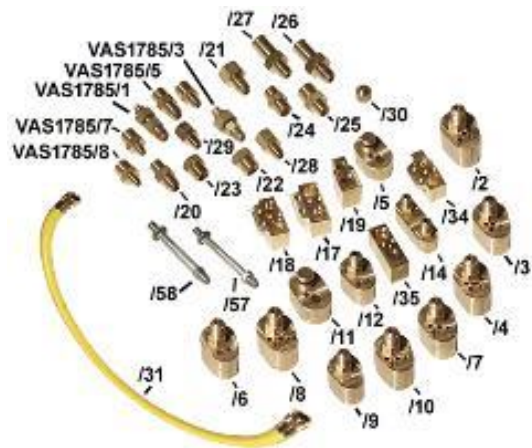
Figure 2. Flushing fitting set.

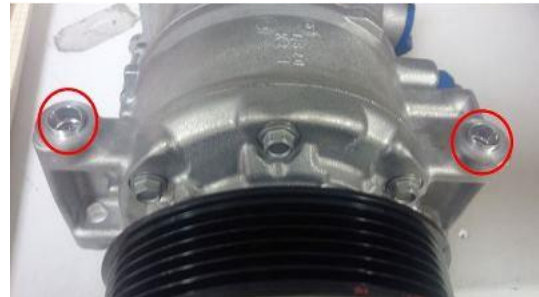
It is imperative that the compressor mounting bolt centering sleeves be reinstalled with the compressor (Figure 3). Failure to reinstall these sleeves will result in compressor failure (as well as possible engine and/or ancillary component damage) in a short period of time. If any sleeves were misplaced during the removal and reinstallation process, new sleeves should be ordered and installed on the compressor housing before reassembly. Compressor or consequential component damage resulting from a failure to install the centering sleeves will not be accepted under warranty.

Figure 3. Mounting bolt centering sleeves on the air conditioning compressor housing.

2. Remove the air conditioning compressor, empty the compressor of the PAG oil completely, then reinstall it to the vehicle. The compressor does not need to be replaced.

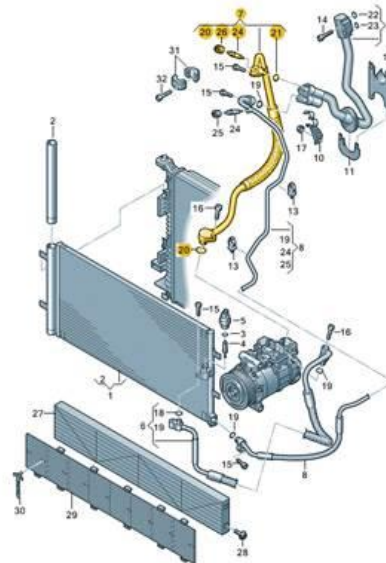
Figure 4. Low side line to be replaced.

3. Replace the low side refrigerant line that connects the air conditioning compressor suction port to the hybrid refrigerant line to the expansion valve (Figure 4). Be certain to use new O-rings at these and all refrigerant circuit joints that are disconnected.

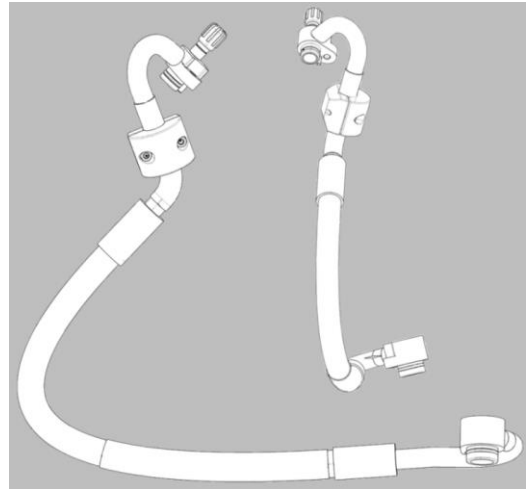
Figure 5. Balance weight position on low side line.

4. Install the balance weight (part number 4G0513621A) to the line in the position shown in the illustration (Figure 5).
