87 Air conditioning does not blow cold

87 17 83 2042340/4 September 25, 2017. Supersedes Technical Service Bulletin Group 87 number 16-78 dated November 9, 2016 for reasons listed below.

Model(s)	Year	VIN Range	Vehicle-Specific Equipment
Q3	2015 - 2016	All	Not Applicable
Q3	2017	000001 - 007836	Not Applicable

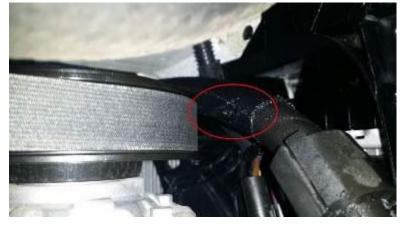
The technical diagnosis reveals that there is no refrigerant in the circuit. The refrigerant hose that connects the suction side of the compressor to the condenser is found to be damaged, as the rubber portion of the hose is making contact with the compressor pulley (Figure 1 and Figure 2).

A production issue with the assembly gauge used during assembly of the hose was found. This issue caused the hose to be assembled with an incorrect geometry. As a result, the lie intended to keep the hose away from the air

conditioning compressor pulley was compromised.

Figure 1. Point of hose contact with air conditioning compressor pulley.

Replace the damaged refrigerant hose and ensure that the natural lie of the hose is away from the air conditioning compressor pulley. Evacuate and recharge the refrigerant circuit and replace any lost PAG oil that may have been discharged from the system. Failure to maintain the correct total amount of PAG oil in the circuit will lead to premature air conditioning compressor failure.

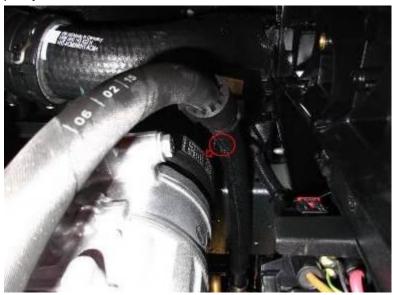
Figure 2. Point of hose contact with air conditioning compressor pulley – rear view.
