# Technical Service Bulletin

## 91 Navigation, Bluetooth, Smartphone Interface, Voice Recognition, Drive select, ACC, or Cruise Control Not Available

91 17 48 2042506/5 September 1, 2017. Supersedes Technical Service Bulletin Group 91 number 16-91 dated November 17, 2016 for reasons listed below.

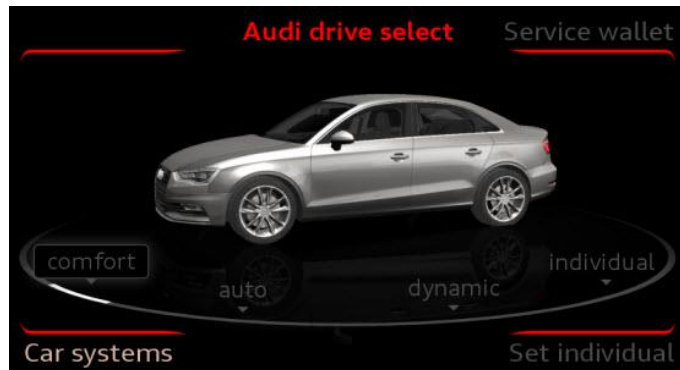
- Audi drive select functions cannot be selected (Figure 1).
- Cruise control does not work (except for A6 and A7) and **DTC P161200** (ECM incorrect coding) is stored in one or more of the control units on the Powertrain CAN bus (address word 0003 (ABS)), (address word 0001 (ECM), etc.).
- Navigation is not activated (Figure 2 and Figure 3).
- Bluetooth is unavailable.
- Audi smartphone interface, including CarPlay or Android Auto, is not available.
- Voice recognition is unavailable (in all cars except A3 Cabriolet. For A3 Cabriolet, see TSB 2038136).

**Figure 1.** Audi drive select functions unavailable and greyed-out.

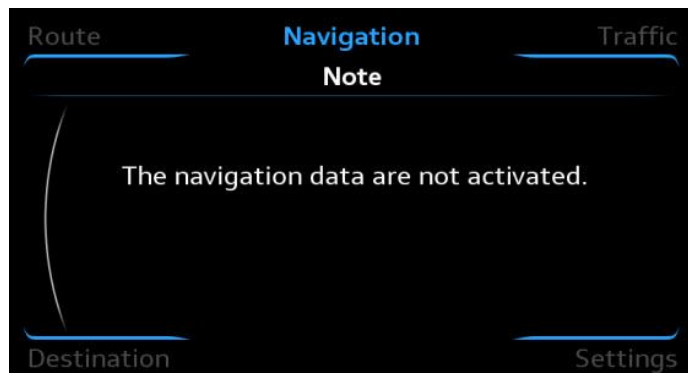
**Figure 2.** Navigation not activated message (Original MIB HMI).

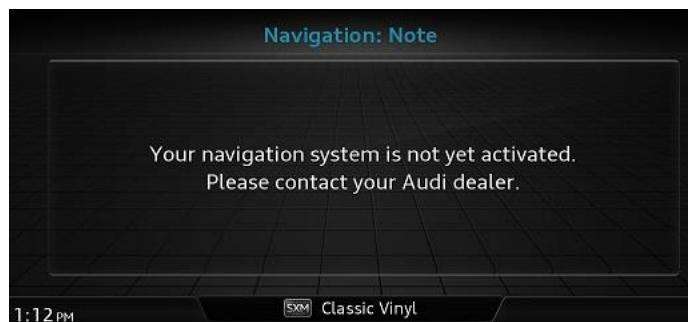
**Figure 3.** Navigation not activated message (New MIB2 HMI).

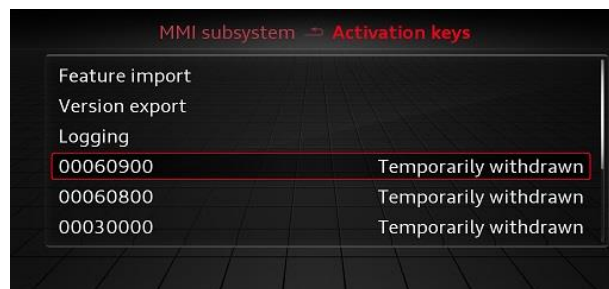
**Temporarily withdrawn or Temp illegal** = This indicates that the SVM activation test plan was not completed (Figure 4). This status is normal for all parts that have been swapped from a different vehicle. Perform the SVM Activations test plan as indicated below, under *Repair Procedure*.

Figure 4. Activation keys showing “Temporarily withdrawn.”
