Technical Service Bulletin

91 MMI connect smartphone app warning messages do not refresh information or remote lock and unlock fails

91 17 51 2044853/4 September 11, 2017. Supersedes Technical Service Bulletin Group 91 number 17-47 dated August 31, 2017 for reasons listed below.

Model(s)	Year	VIN Range	Vehicle-Specific Equipment
A4, Q7	2017 - 2019	All	With Audi connect
A5, Q5	2018 - 2019	All	With Audi connect

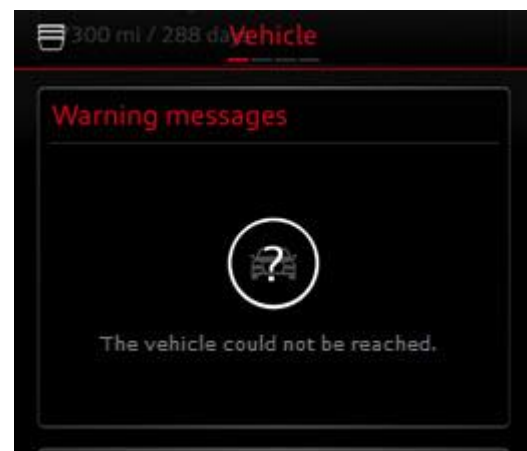
- The function "Warning messages" does not provide new data when the user manually attempts to refresh the data. An error message stating "The vehicle cannot be reached" can be seen in the app and the myAudi web site (Figure 1).
- The vehicle cannot be locked or unlocked with the app, and an error message stating "A technical error occurred" is displayed (Figure 2).

Figure 1. Warning messages cannot be refreshed.

This error indicates the Audi connect backend cannot contact the vehicle. This can be caused by multiple reasons:

1. There is a current Audi connect backend problem causing an outage of services.
2. The vehicle is parked in an area where AT&T 3G reception is poor.
3. The vehicle battery is low and the vehicle systems cannot be woken up due to energy management.
4. There is a software issue with the connected data bus on board diagnostic interface, J533 (address word 0019).
5. There is a wiring or other vehicle issue preventing the connected data bus on board diagnostic interface, J533 (address word 0019) from communicating with the Audi connect backend.

If the vehicle was built prior to CW22/17 (check ElsaPro because some MY2018 vehicles are pull-ahead cars which were built prior to CW22/17), and the customer is already a verified Key User of the vehicle (Key user pairing is active in the MMI), then update the software of the connected data bus on board diagnostic interface, J533 (address word 0019).

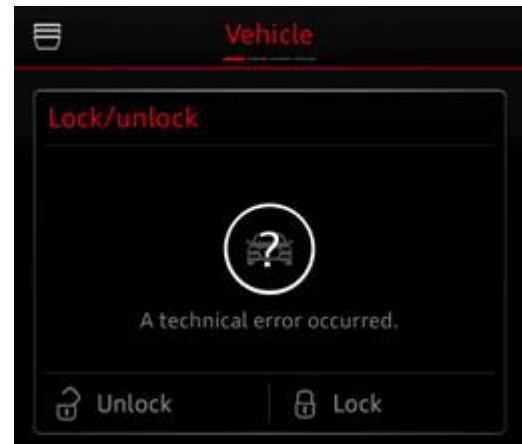
Figure 2. Lock/unlock error.

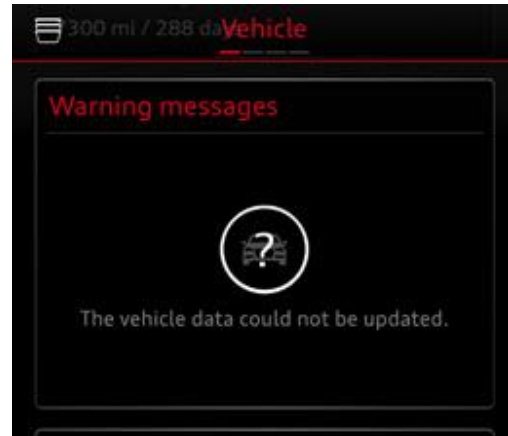
Tip: Not all errors in the MMI connect app indicate a problem. For example, the message “The vehicle data could not be updated” is displayed when the engine is on or when the vehicle is being driven, as data is not refreshed under these conditions (Figure 3).

Figure 3. Normal condition warning message.

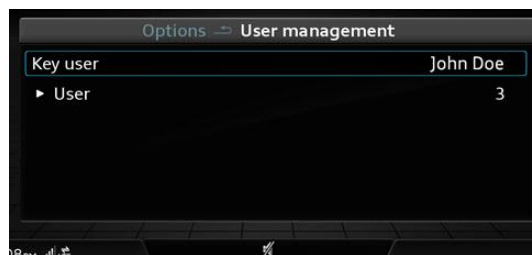
1. Verify the customer's name is showing as an active Key User of the vehicle. In the MMI, navigate to *MENU >> Audi connect*, then the right option and choose *Audi connect user management*. If the customer is a Key User, his or her myAudi registered name will be listed (Figure 4).

Figure 4. Key User assigned with three secondary users.
