Technical Service Bulletin

91 MIB1 Audi connect and Online Services Inoperative with SIM not recognized

91 17 52 2045723/3 September 25, 2017. Supersedes Technical Service Bulletin Group 91 number 17-05 dated January 26, 2017 for reasons listed below.

Model(s)	Year	VIN Range	Vehicle-Specific Equipment
A3	2015 - 2016	All	MIB High with Audi connect

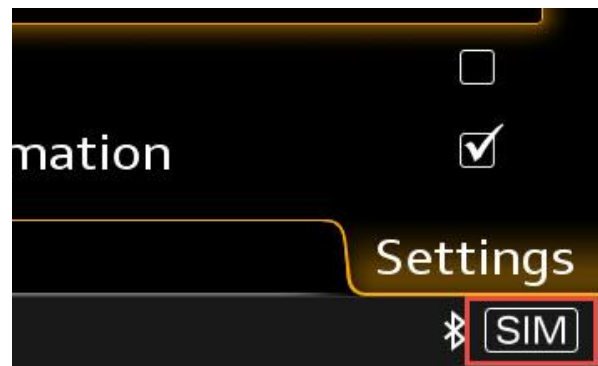
The customer states that there are no online services available via the inserted SIM card. The inserted SIM card cannot be recognized by the MMI (Figure 1).

Figure 1. SIM not recognized

The internal USB port for the phone module cannot be initialized. Therefore the phone module is not recognized in the information electronics control module 1, J794 (address word 005F) and any SIM inserted into the MMI cannot be utilized.

1. The SIM card in the Information electronics control module 1 is not recognized as seen in Figure 1. If data signal bars are seen then this TSB does not apply. For this scenario the customer's data plan has either reached its limit or the Audi connect subscription account is not active.

If it is determined the customer's SIM card and Audi connect subscription are okay, and the SIM cannot be recognized in the customer's MMI, then the telephone module must be replaced in the MMI.

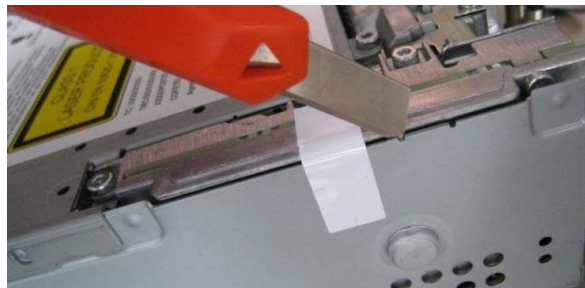
Figure 8. Warranty Seal.

8. Cut through the seal of the unit using the utility knife (Figure 8).

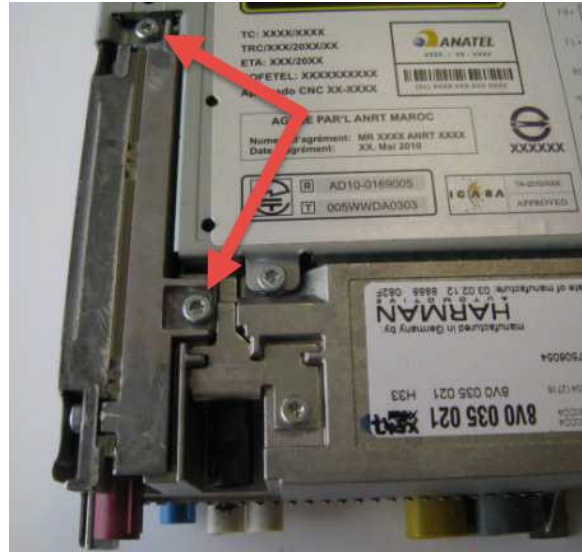
Figure 9. Telephone Module Screws.

9. Remove the two screws holding the telephone module (arrows in Figure 9).

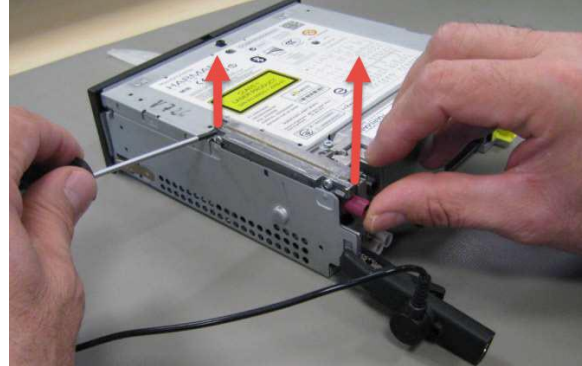
Figure 10. Lift up on both ends.

10. Lift the phone module on the inner end in direction of the arrow and at the same time on the outer end (Figure 10).

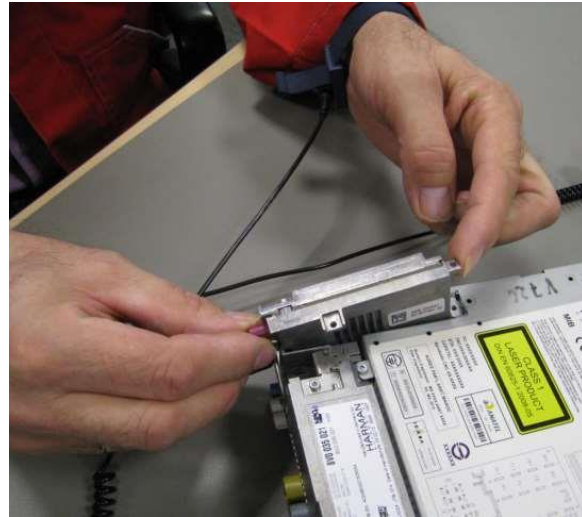
Figure 11. Remove the top out first.

11. Completely take out the phone module towards the top (Figure 11).

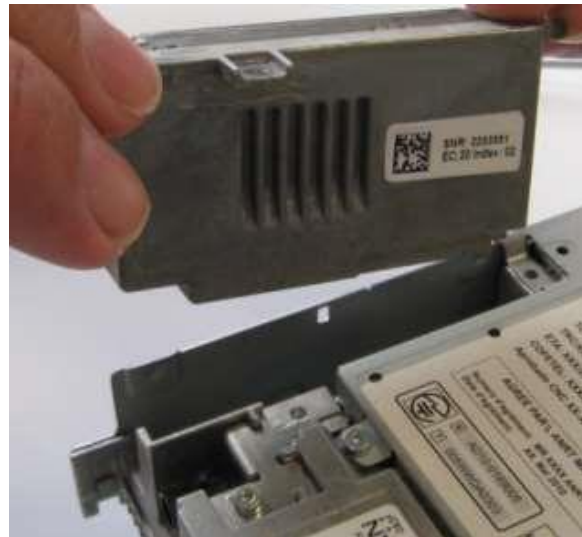
Figure 12. Insert the new telephone module.

12. Place the new phone module downwards into the channel and carefully press in the contacts (Figure 12).

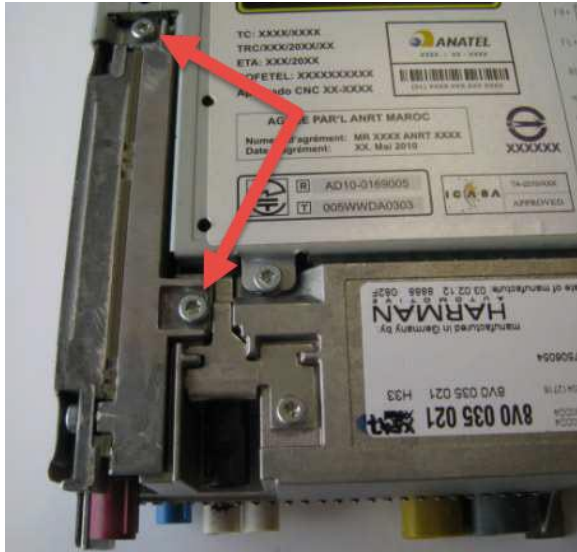
Figure 13. Do not over torque screws.

13. Slightly tighten the module with the supplied screws (arrows in Figure 13).

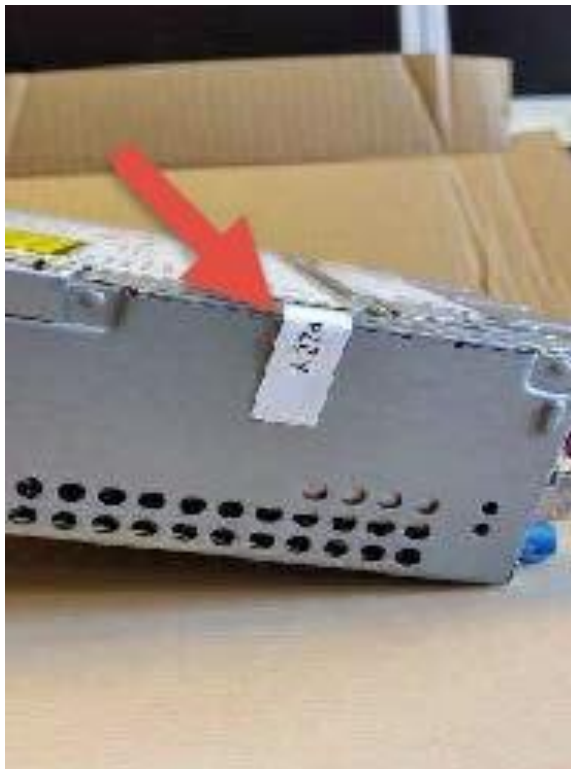
Figure 14. Apply new warranty label.

14. Stick the supplied repair sticker with the label - A 274 - on the information electronics control module 1, J794 (address word 005F) (Figure 14).
