Technical Service Bulletin

91 MIB2 Scale: Radio preset selected without input from control panel

91 17 53 2048535/1 September 26, 2017.

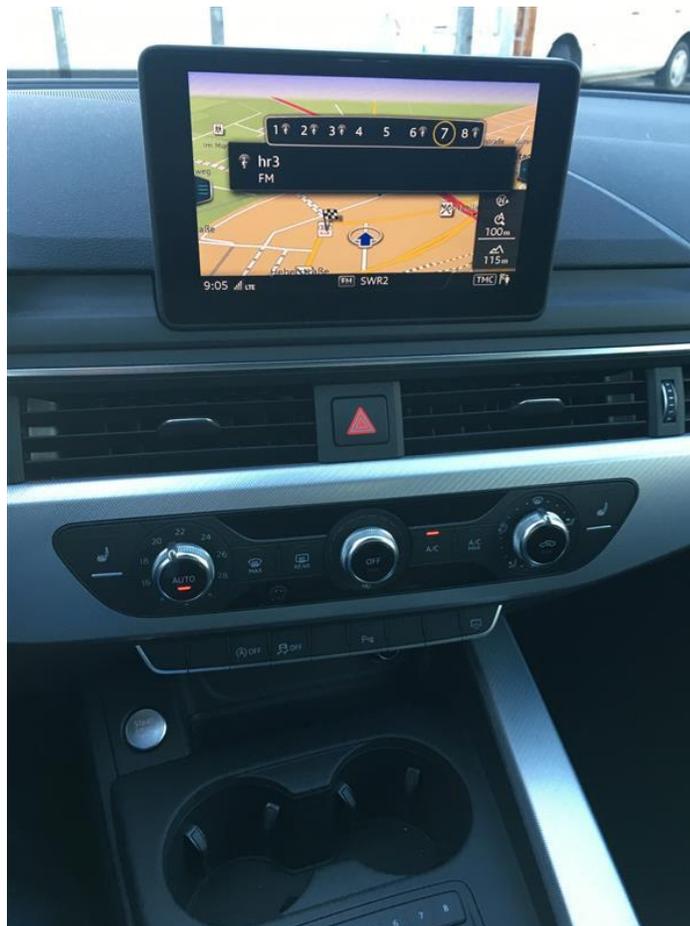
Customer may report that the radio preset buttons activate without pressing the button (Figure 1).

Figure 1. Radio station preset activated.

Internal connection concern can cause invalid signals to be sent to the main control module.

Improved MMI control panel.

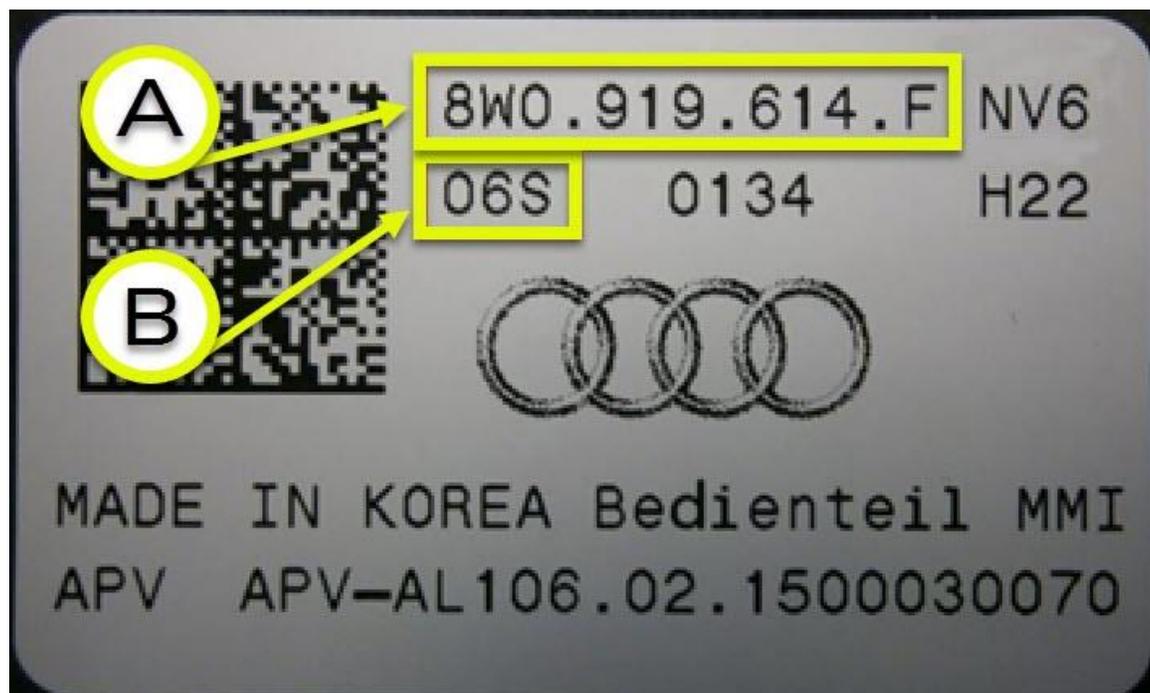
2. Remove the MMI control panel, refer to the workshop manual for instruction.
3. Inspect the label of the MMI control panel for the Hardware Number (Figure 2A) and Version Number (Figure 2B).

Figure 2. A: Hardware Number. B: Hardware Version.

4. If the hardware number of the removed part is found in the table (Figure 3), and the hardware version number is equal to or lower than the corresponding hardware version, replace the MMI Control Panel. Consult the parts catalog for part number.
